# Testing Evaluation Laboratories, Inc.

## TEST RESULTS

**Project Summary:** Testing Evaluation Laboratories, Inc. (TEL) was contracted by Fleetwood Windows and Doors to perform tests on the Kona 3800 Casement and Awning Windows at TEL's Plant City, FL test facility.

**Series / Model:** Kona 3800 Casement and Awning Windows  
**Type:** Aluminum Awning Window  
**Overall Size:** 65.00" x 42.00" – (X)  
**Daylight Opening:** 56.63" x 33.88" – (X)  
**Glazing Detail:** See attached drawing numbers L-7033A for glazing details.  
**Frame Material:** Aluminum  
**Finish:** Mill Finish

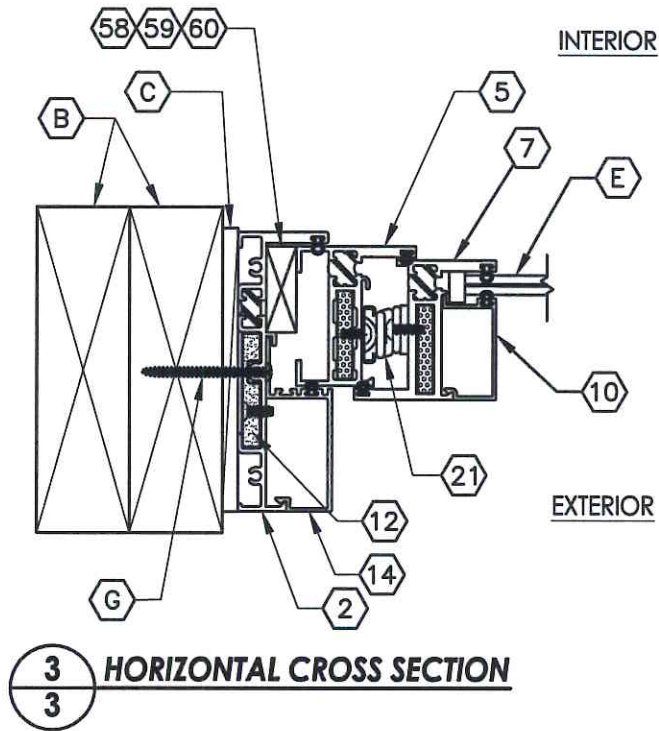
NOTE:  
1. Item #35 located 17"  
from each end (2) total.

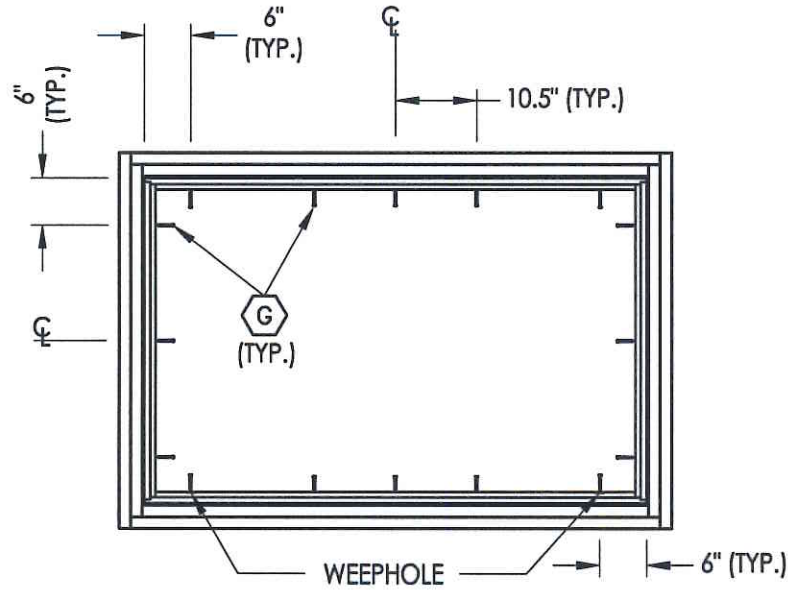
PART OR ASSEMBLY: FRAME ANCHORING

**FRAME ANCHORING**  
2X buck construction

For Tested Elevation, Vertical Cross Sections, Horizontal Cross Sections, Components, Frame Anchoring, Glazing Detail and Bill of Materials See Attached Drawing number L-7033A.
