ASTM E 1886-05 / ASTM E 1996-09
Missile Level "D" (Includes Wind Zone 4)

3900-T Side Hinged Doors

Report No: TEL 01991349
Test Dates: March 16, 2015
through April 3, 2015
Report Date: June 26, 2015

Project Summary: Testing Evaluation Laboratories, Inc. (TEL) was contracted by Fleetwood Windows and Doors to perform tests on the 3900-T Side Hinged Doors at TEL's Plant City, FL test facility.

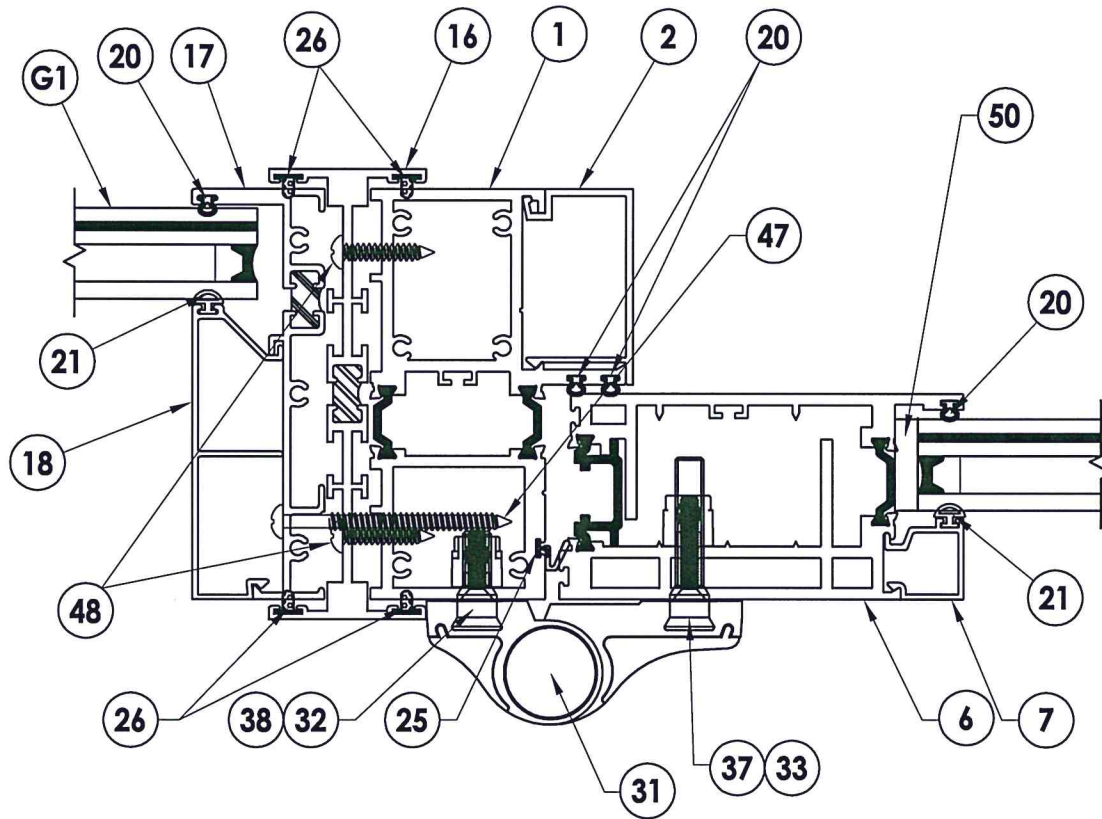
1
4 **HORIZONTAL CROSS SECTION**

PRODUCT:
FLEETWOOD
SPEC. 6, 6A

PART OR ASSEMBLY:
HORIZONTAL
CROSS SECTIONS

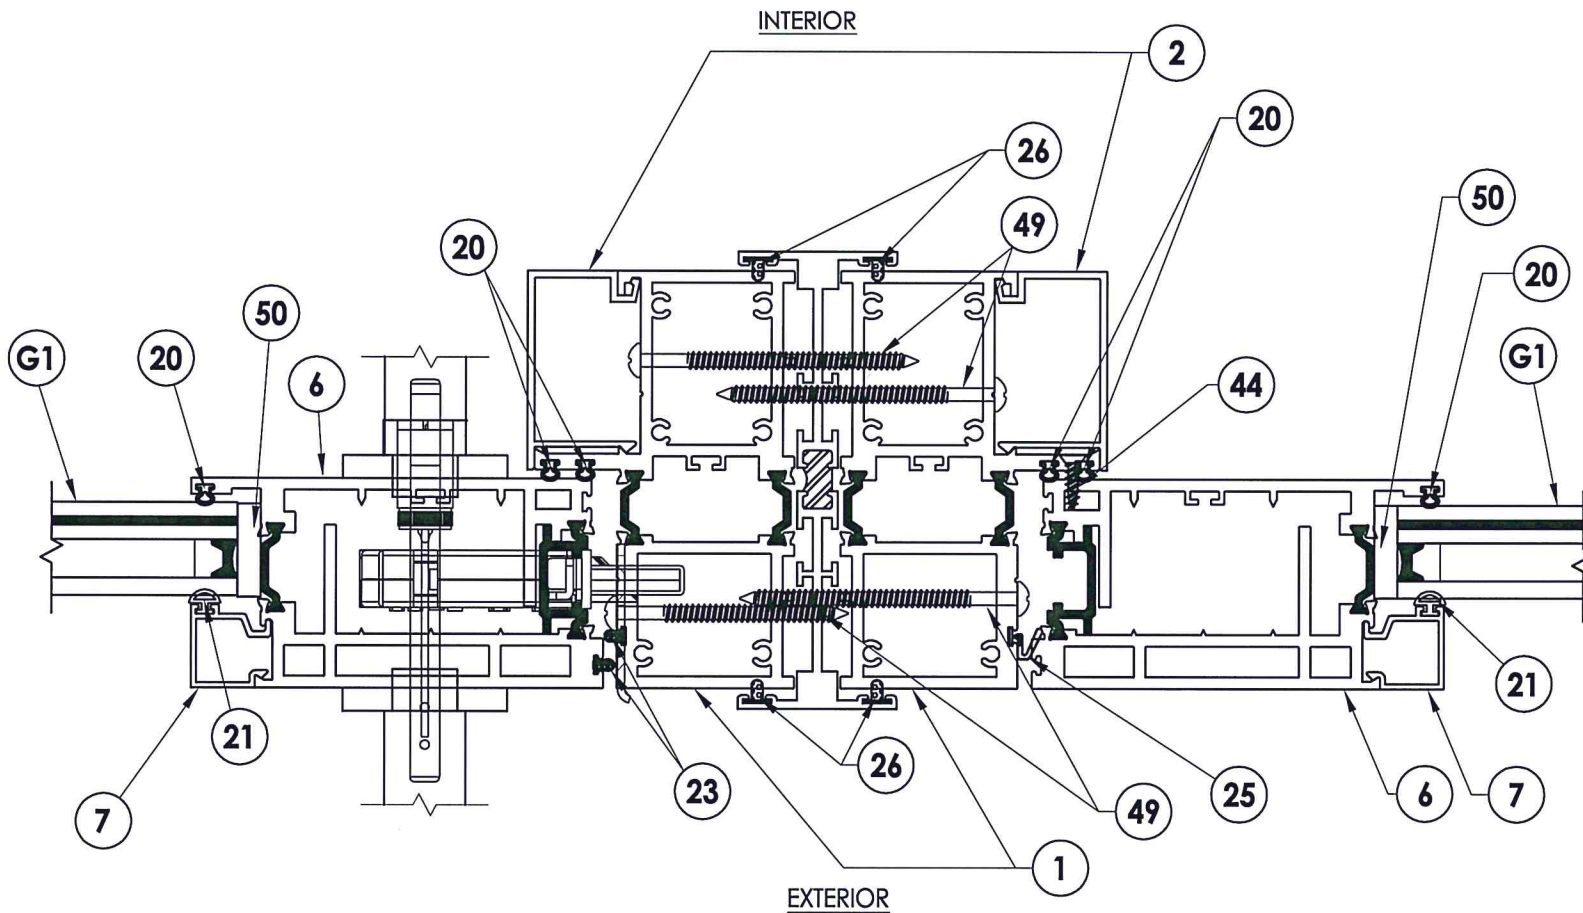
1
5 **HORIZONTAL CROSS SECTION**

PRODUCT:		FLEETWOOD SPEC. 6, 6A	
PART OR ASSEMBLY:		HORIZONTAL CROSS SECTIONS	
NO.	DATE	BY	REVISIONS
<div style="border: 1px solid black; padding: 5px;"> RW BUILDING CONSULTANTS, INC. 813.659.9197 </div>			
DATE: 4/4/15			
SCALE: N.T.S.			
DWG. BY: JK			
CHK. BY: LFS			
DRAWING NO.: L-7349			
SHEET 5 OF 17

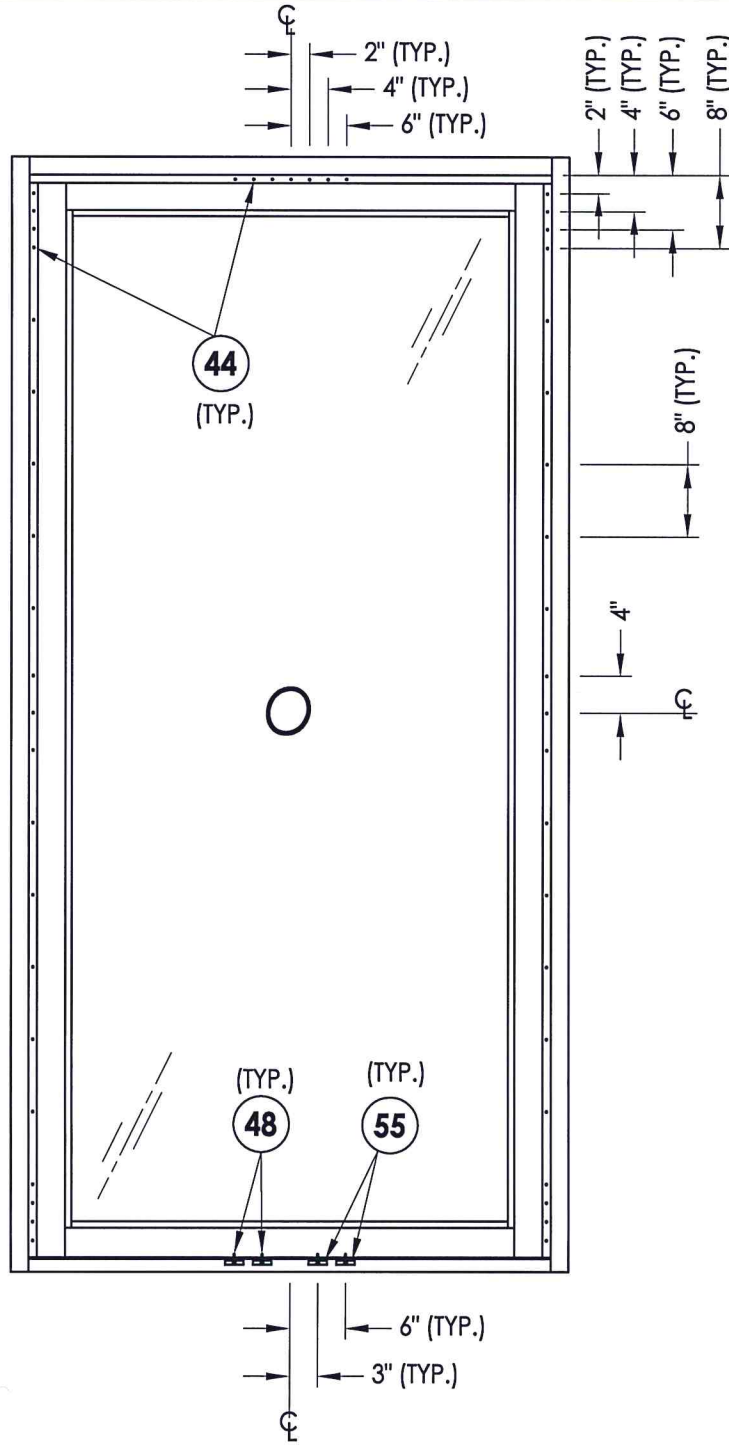
PRODUCT:		FLEETWOOD SPEC. 6, 6A	
PART OR ASSEMBLY:		SIDELITE PANEL DETAIL

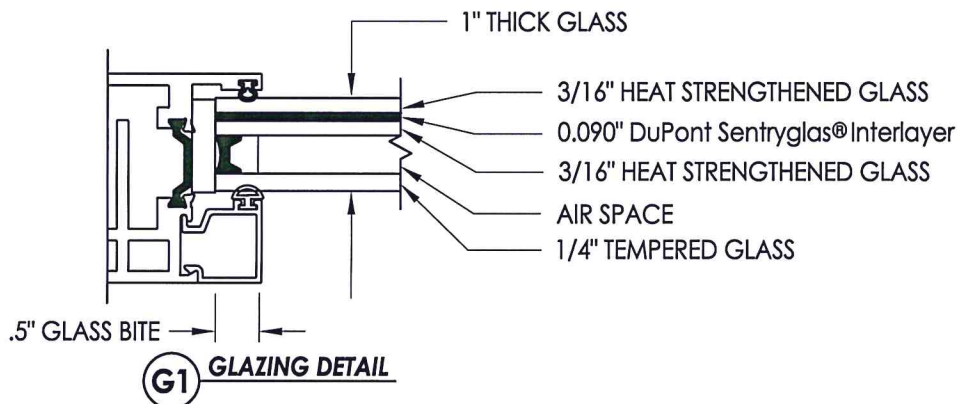
17 KONA FRAME

PRODUCT: FLEETWOOD SPEC. 6, 6A		PART OR ASSEMBLY: COMPONENTS AND GLAZING DETAIL	
NO.	DATE	REVISIONS	BY
<div style="border: 1px solid black; padding: 5px; text-align: center;"> RW BUILDING CONSULTANTS, INC. 813.659.9197 </div>			
DATE: 4/4/15			
SCALE: N.T.S.			
DWG. BY: JK			
CHK. BY: LFS			
DRAWING NO.: L-7349			
SHEET 15 OF 17

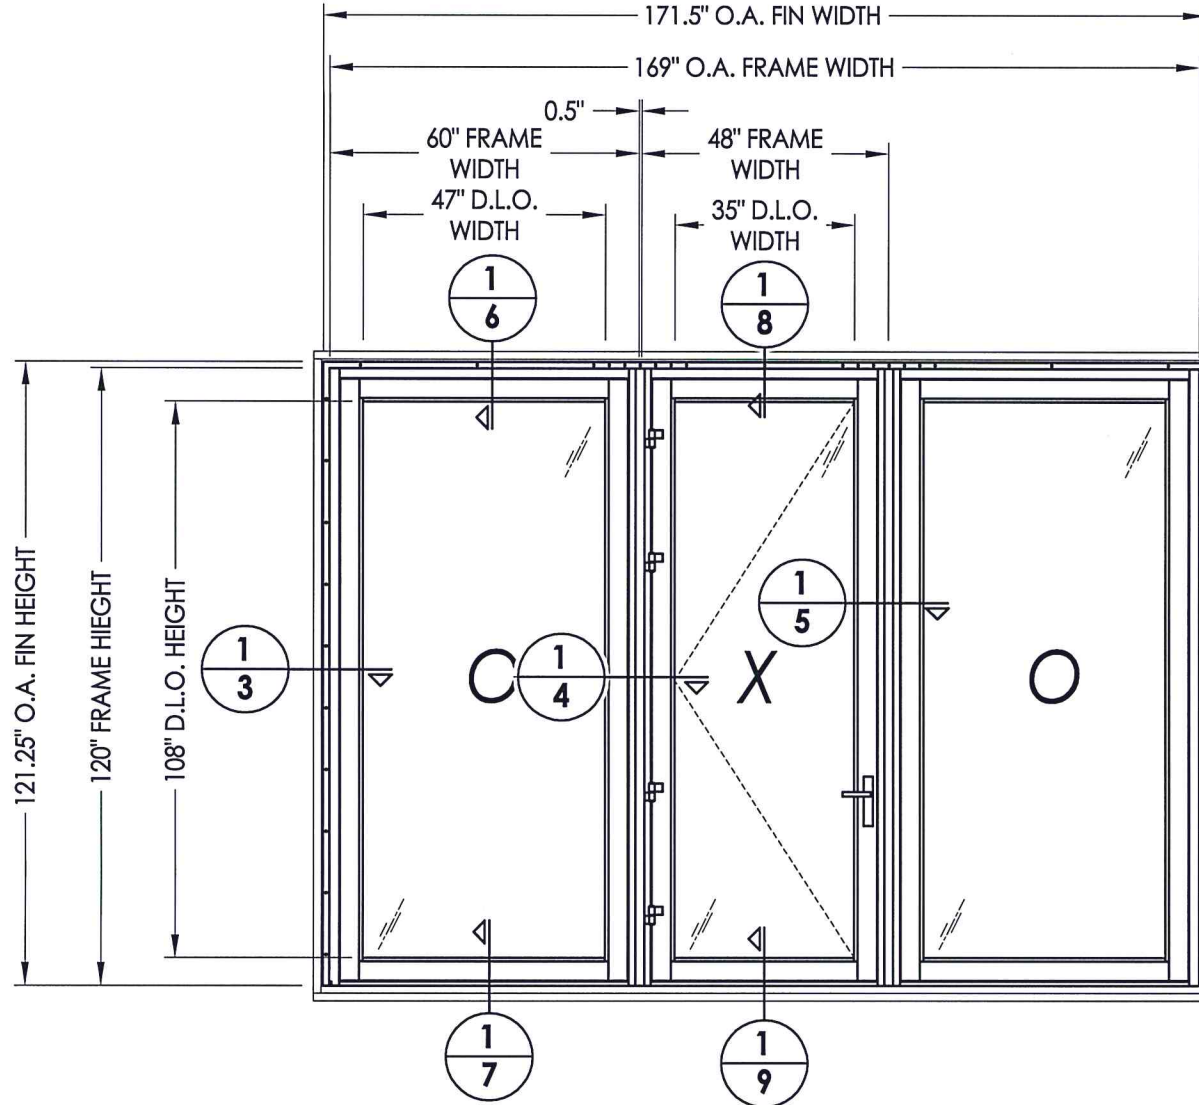
<u>PRODUCT:</u>		<u>PART OR ASSEMBLY:</u>	
FLEETWOOD SPEC. 6C, 6D, 6E		TEST ELEVATIONS

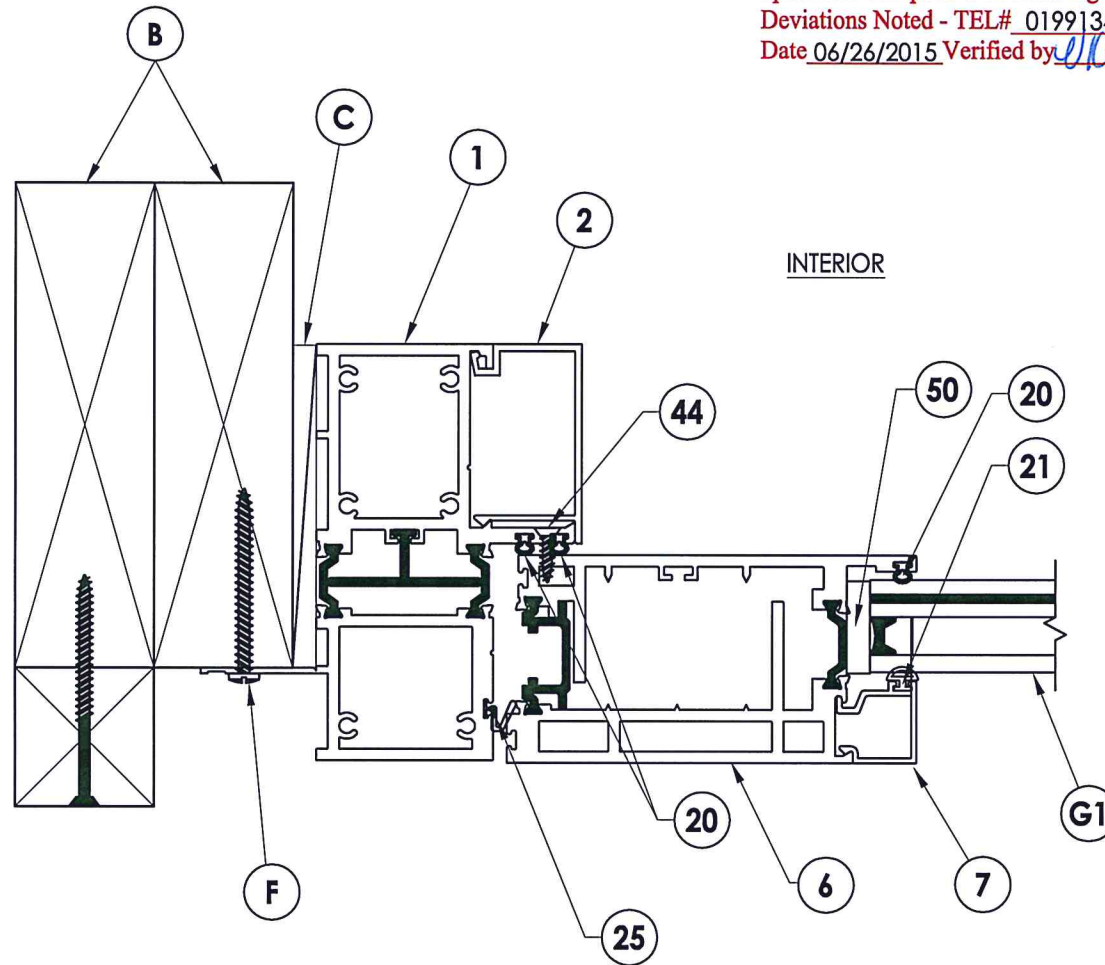
1
3 **HORIZONTAL CROSS SECTION**

PRODUCT: FLEETWOOD SPEC. 6C, 6D, 6E		PART OR ASSEMBLY: HORIZONTAL CROSS SECTIONS	
		NO.	DATE
		BY	REVISIONS
<div style="border: 1px solid black; padding: 5px; text-align: center;"> RW BUILDING CONSULTANTS, INC. 813.659.9197 </div>			
DATE: 4/4/15			
SCALE: N.T.S.			
DWG. BY: JK			
CHK. BY: LFS			
DRAWING NO.: L-7349A			
SHEET 3 OF 14

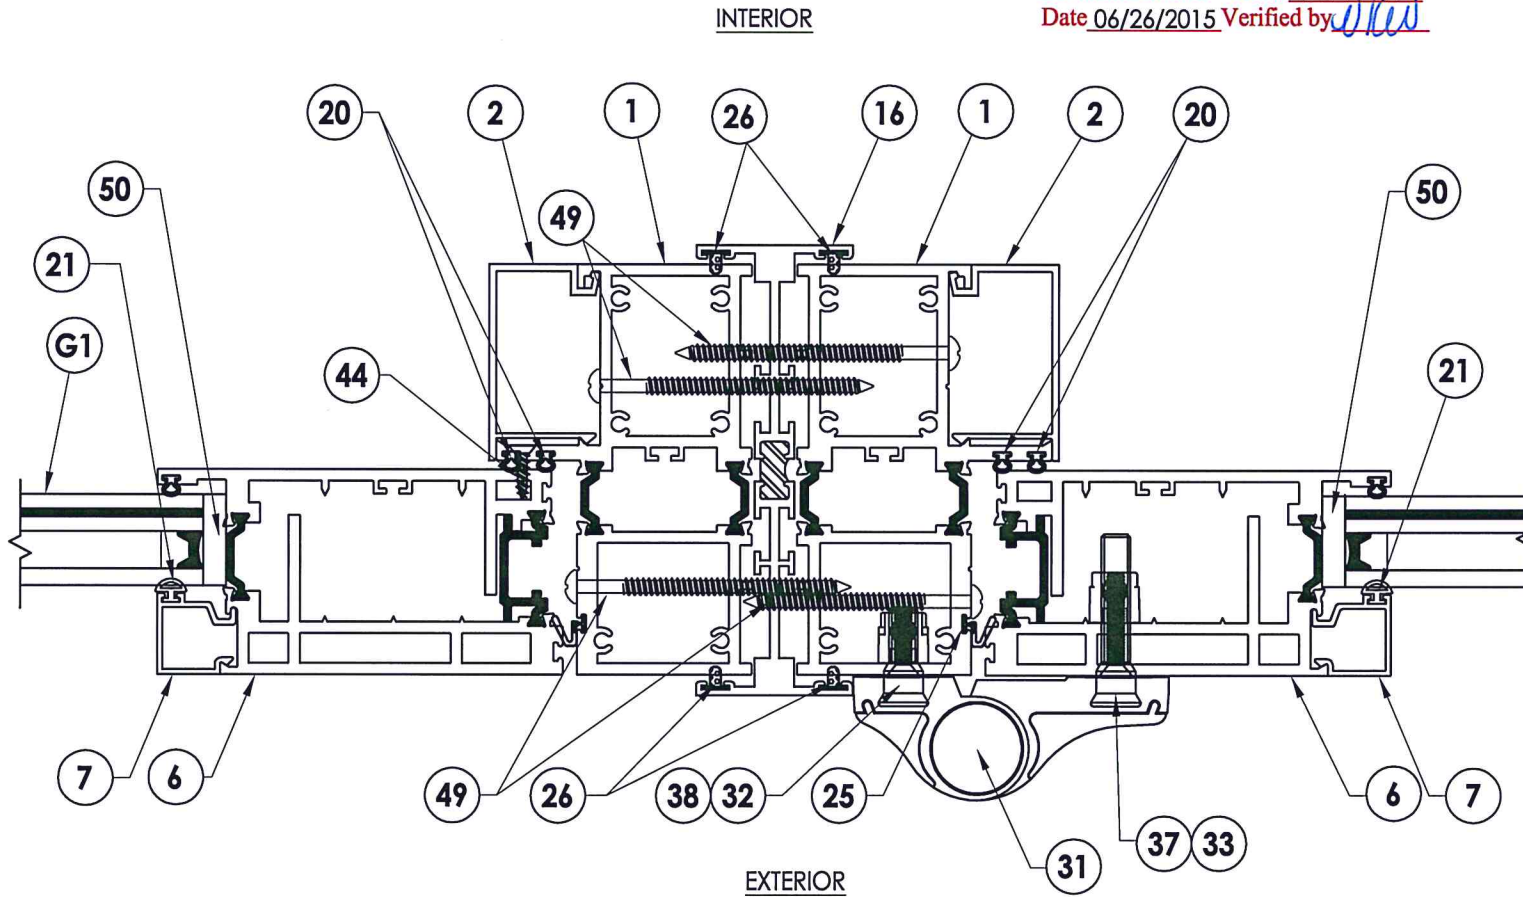
1
4 **HORIZONTAL CROSS SECTION**

PRODUCT:		FLEETWOOD SPEC. 6C, 6D, 6E	
PART OR ASSEMBLY:		HORIZONTAL CROSS SECTIONS	
NO.	DATE	BY	REVISIONS
RW BUILDING CONSULTANTS, INC. 813.659.9197			
DATE: 4/4/15			
SCALE: N.T.S.			
DWG. BY: JK			
CHK. BY: LFS			
DRAWING NO.: L-7349A			
SHEET 4 OF 14

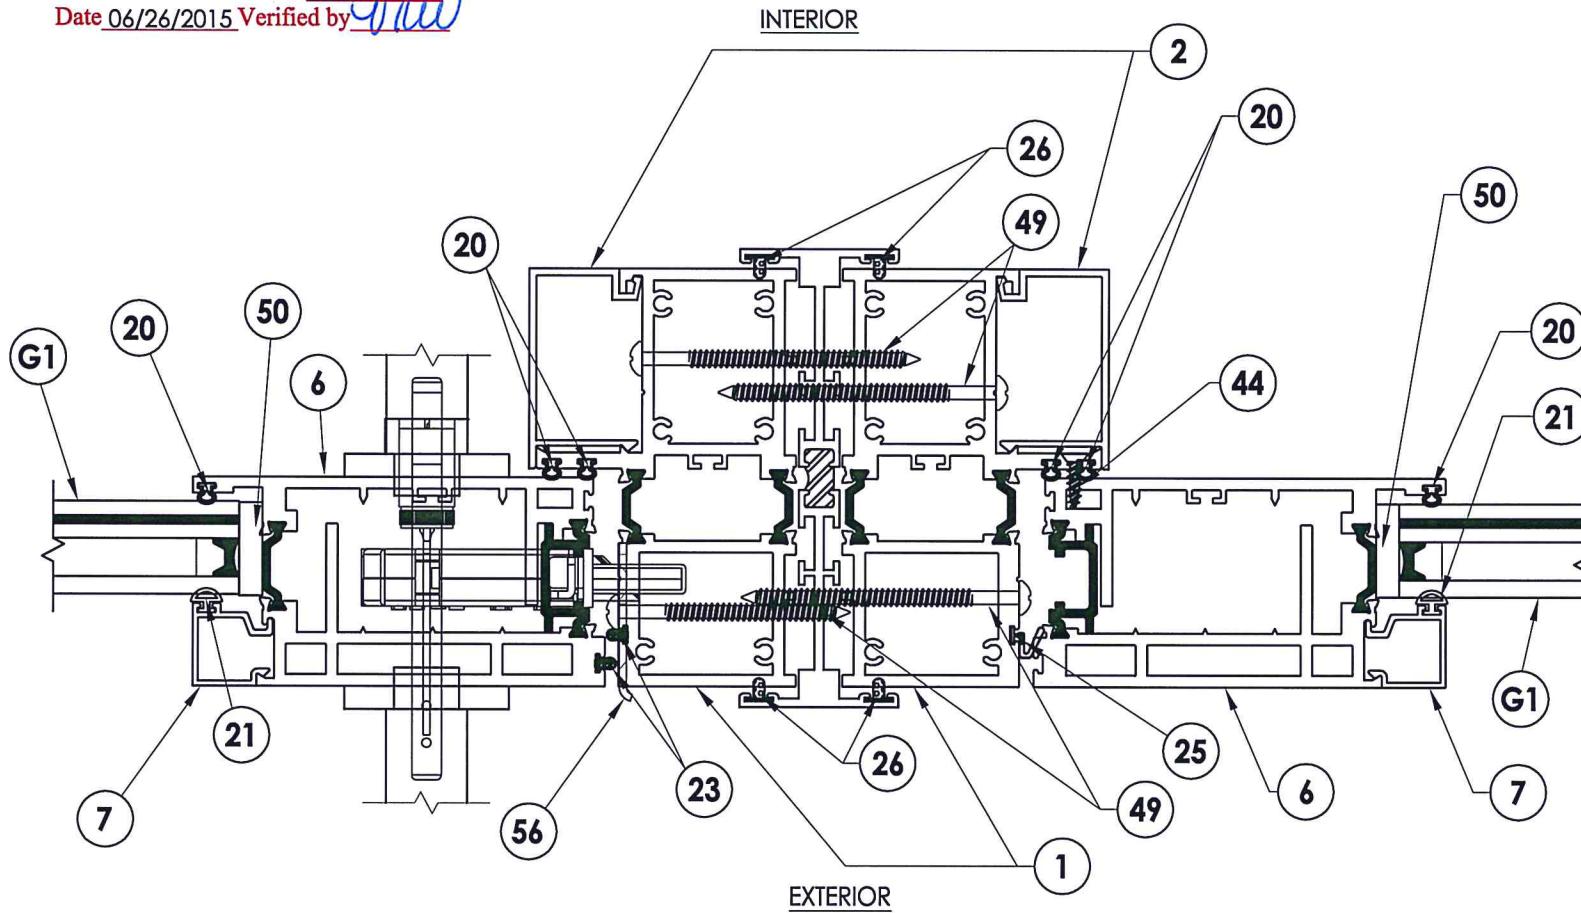
1
5 **HORIZONTAL CROSS SECTION**

PRODUCT:
 FLEETWOOD
 SPEC. 6C, 6D, 6E

PART OR ASSEMBLY:
 VERTICAL
 CROSS SECTIONS

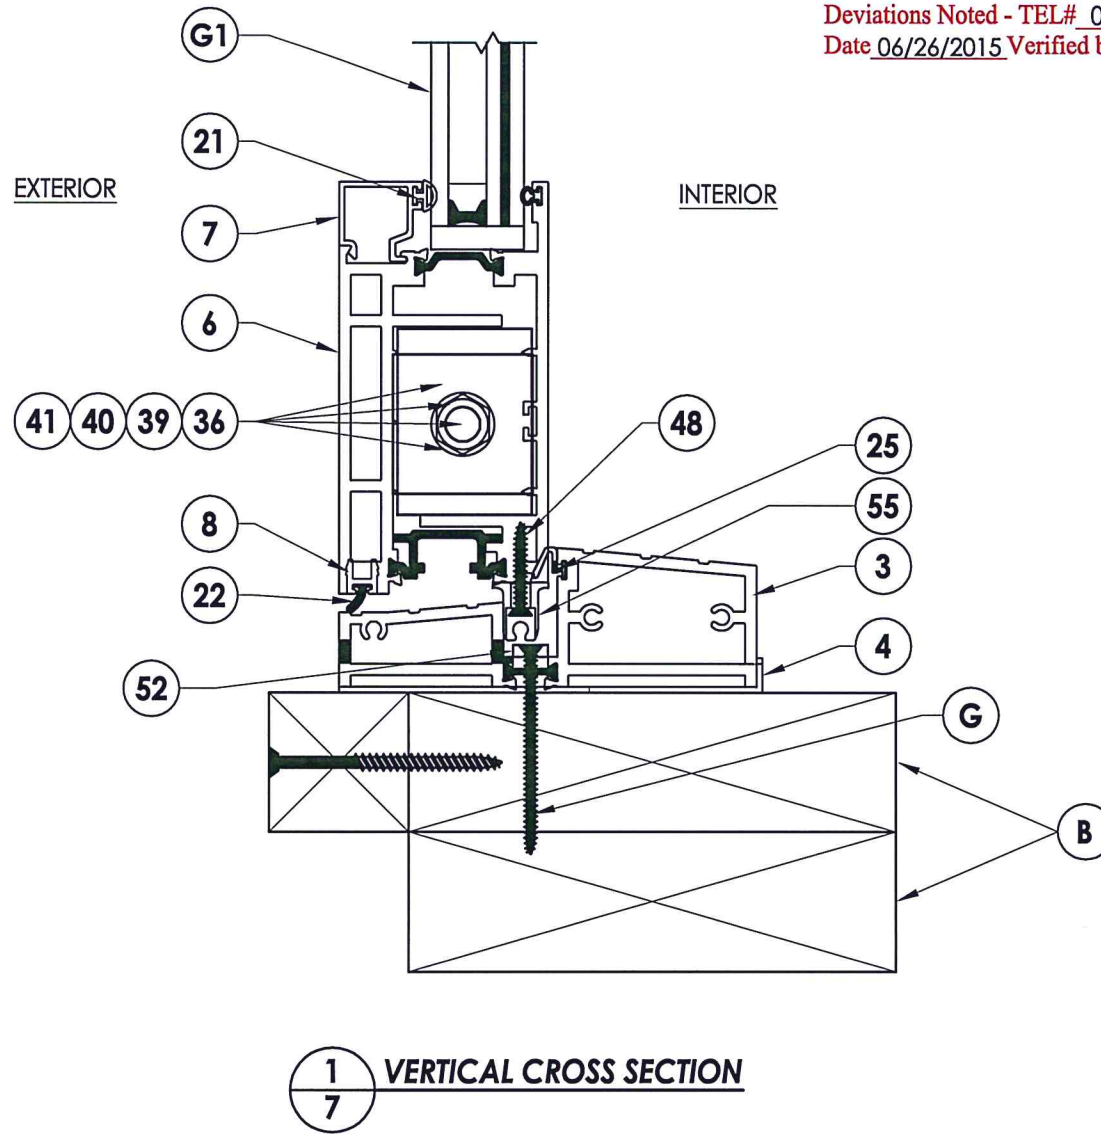
PRODUCT:		FLEETWOOD SPEC. 6C, 6D, 6E	
PART OR ASSEMBLY:		VERTICAL CROSS SECTIONS	
NO.	DATE	BY	REVISIONS
<div> <div>RW BUILDING CONSULTANTS, INC. 813.659.9197</div> <div> DATE: 4/4/15 SCALE: N.T.S. DWG. BY: JK CHK. BY: LFS DRAWING NO.: L-7349A SHEET 7 OF 14 </div> </div>

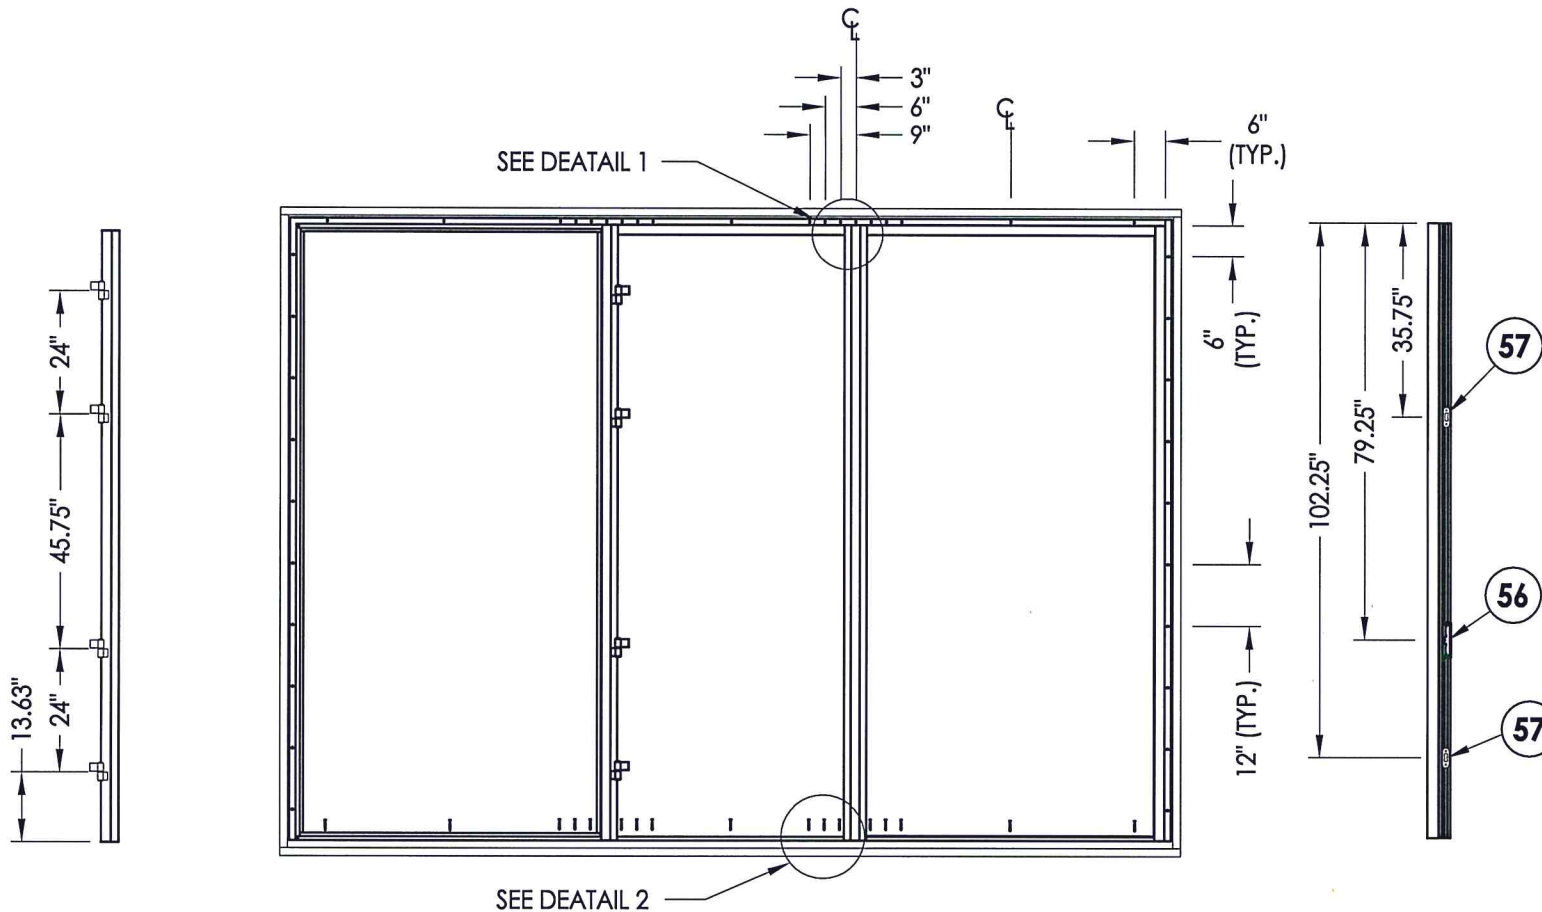
HINGE JAMB

FRAME ANCHORING
(2X buck installation)

STRIKE JAMB

DETAIL 2

DETAIL 1

<u>PRODUCT:</u> FLEETWOOD SPEC. 6C, 6D, 6E				<u>PART OR ASSEMBLY:</u> FRAME ANCHORING

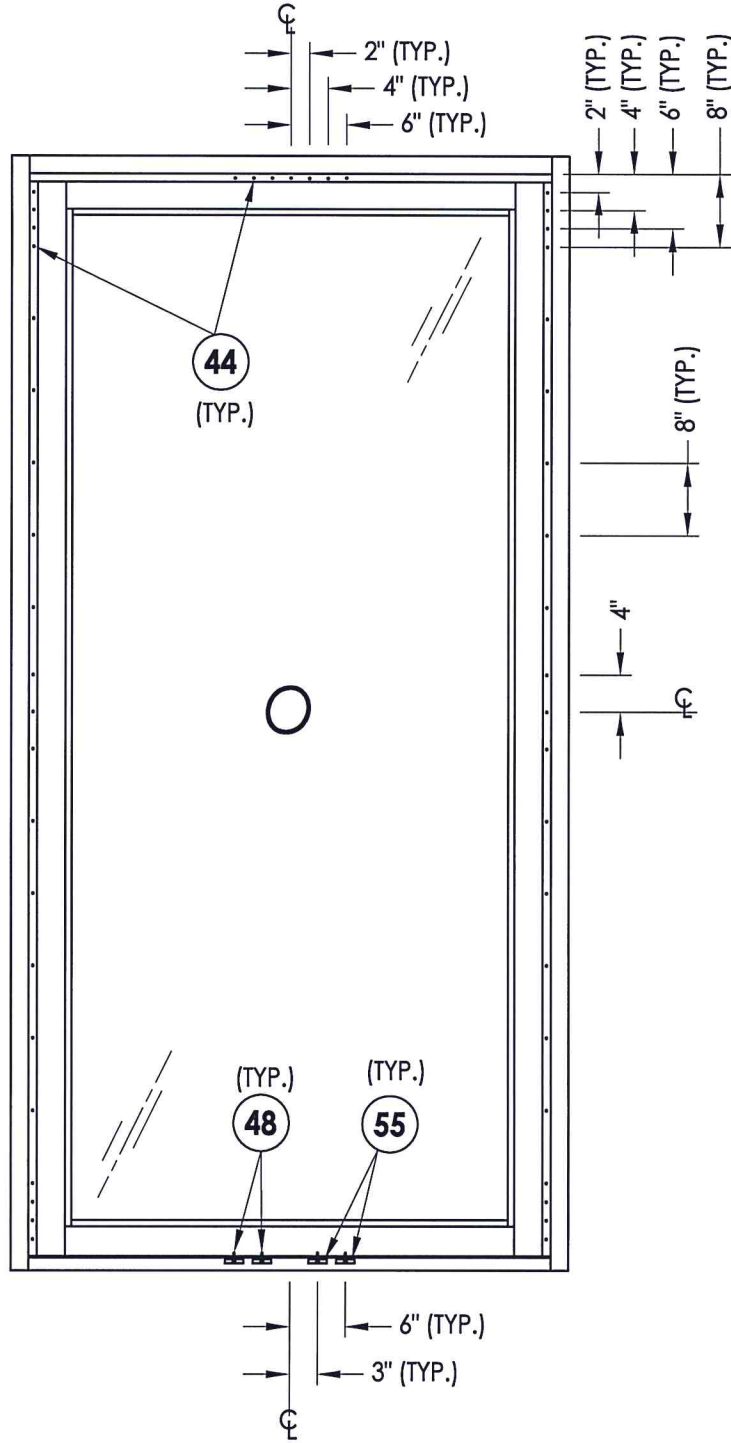
PRODUCT:		FLEETWOOD SPEC. 6C, 6D, 6E	
PART OR ASSEMBLY:		SIDELITE PANEL DETAIL	
</

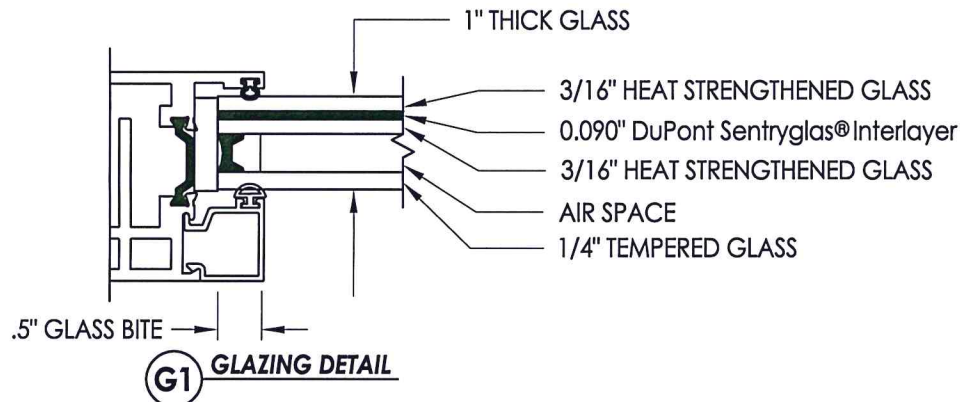
G1 GLAZING DETAIL

PRODUCT:		FLEETWOOD SPEC. 6C, 6D, 6E	
PART OR ASSEMBLY:		COMPONENTS AND GLAZING DETAIL	
NO.	DATE	REVISIONS	BY
<div style="border: 1px solid black; padding: 5px; text-align: center;"> RW BUILDING CONSULTANTS, INC. 813.659.9197 </div>			
DATE: 4/4/15			
SCALE: N.T.S.			
DWG. BY: JK			
CHK. BY: LFS			
DRAWING NO.: L-7349A			
SHEET 12 OF 14
