MIAMI-DADE COUNTY PERFORMANCE TEST REPORT

Report No.: E8390.03-301-18

Rendered to: FLEETWOOD WINDOWS AND DOORS Corona, California

PRODUCT TYPE: Sliding Door **SERIES/MODEL**: 3070-T Corner Door/Pocket Door

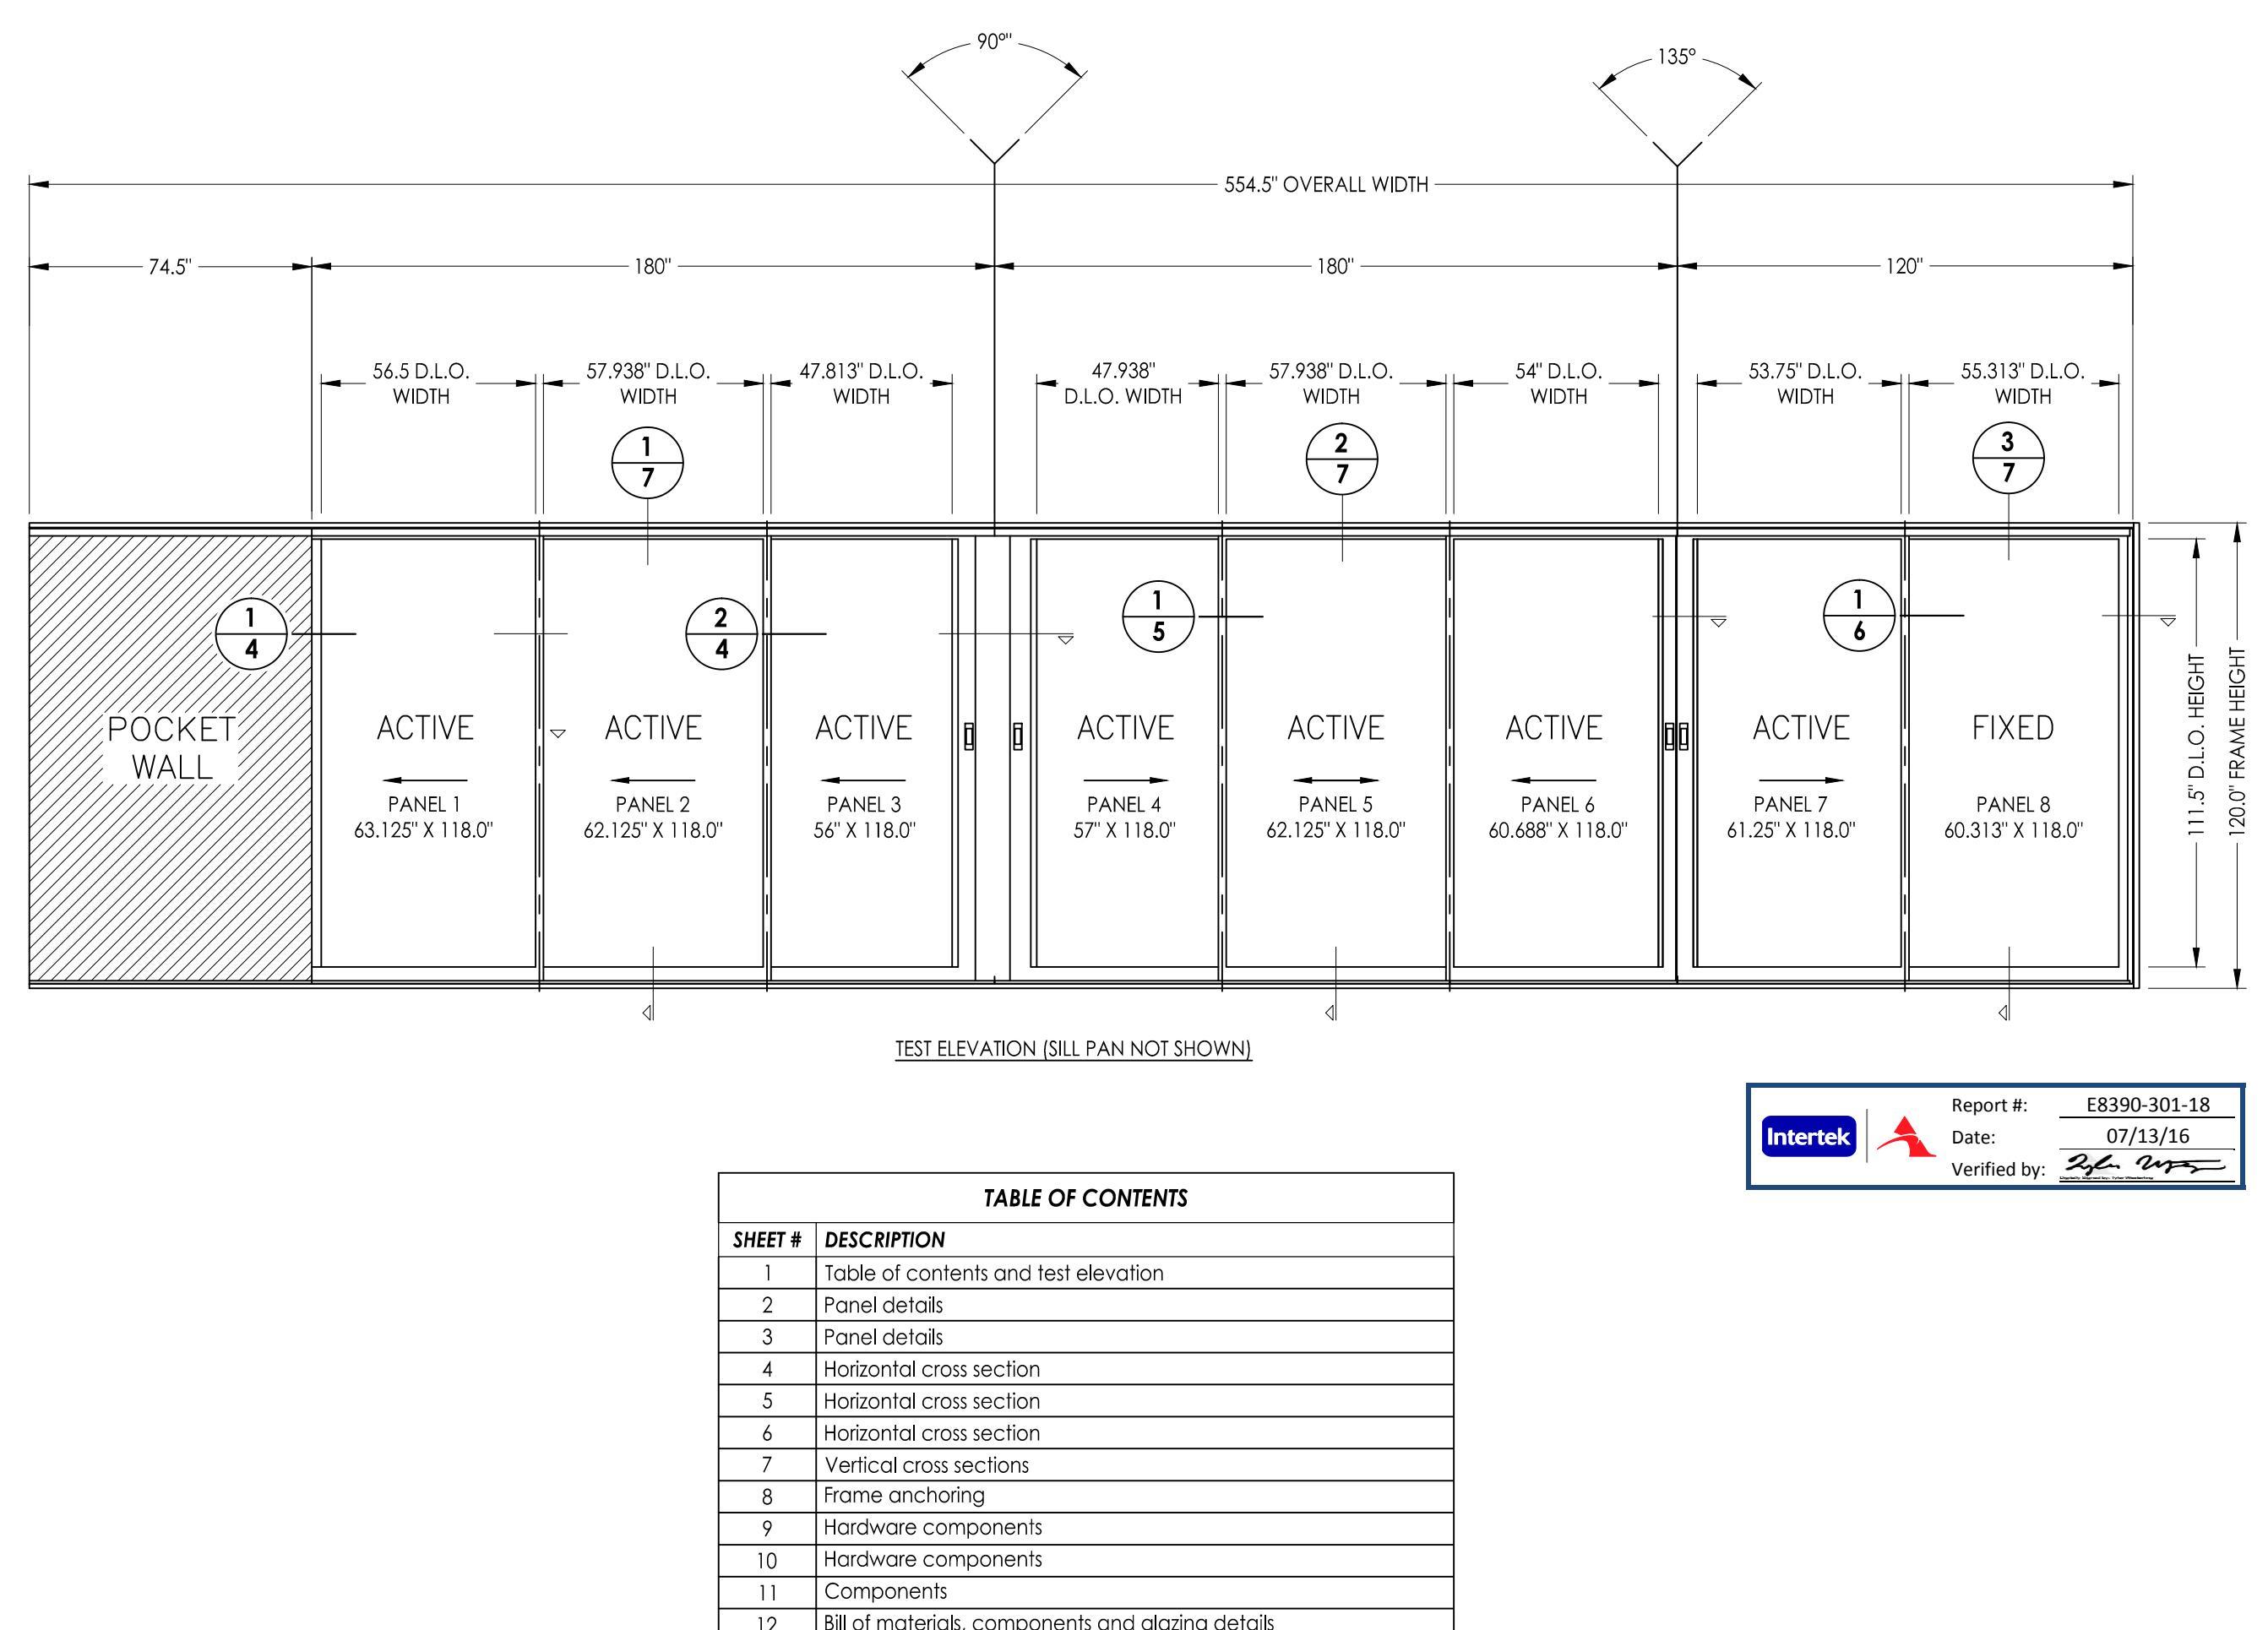
TABLE OF CONTENTS				
SHEET #	DESCRIPTION			
1	Table of contents and test elevation			
2	Panel details			
3	Panel details			
4	Horizontal cross section			
5	Horizontal cross section			
6	Horizontal cross section			
7	Vertical cross sections			
8	Frame anchoring			
9	Hardware components			
10	Hardware components			
11	Components			
12	Bill of materials, components and glazing details

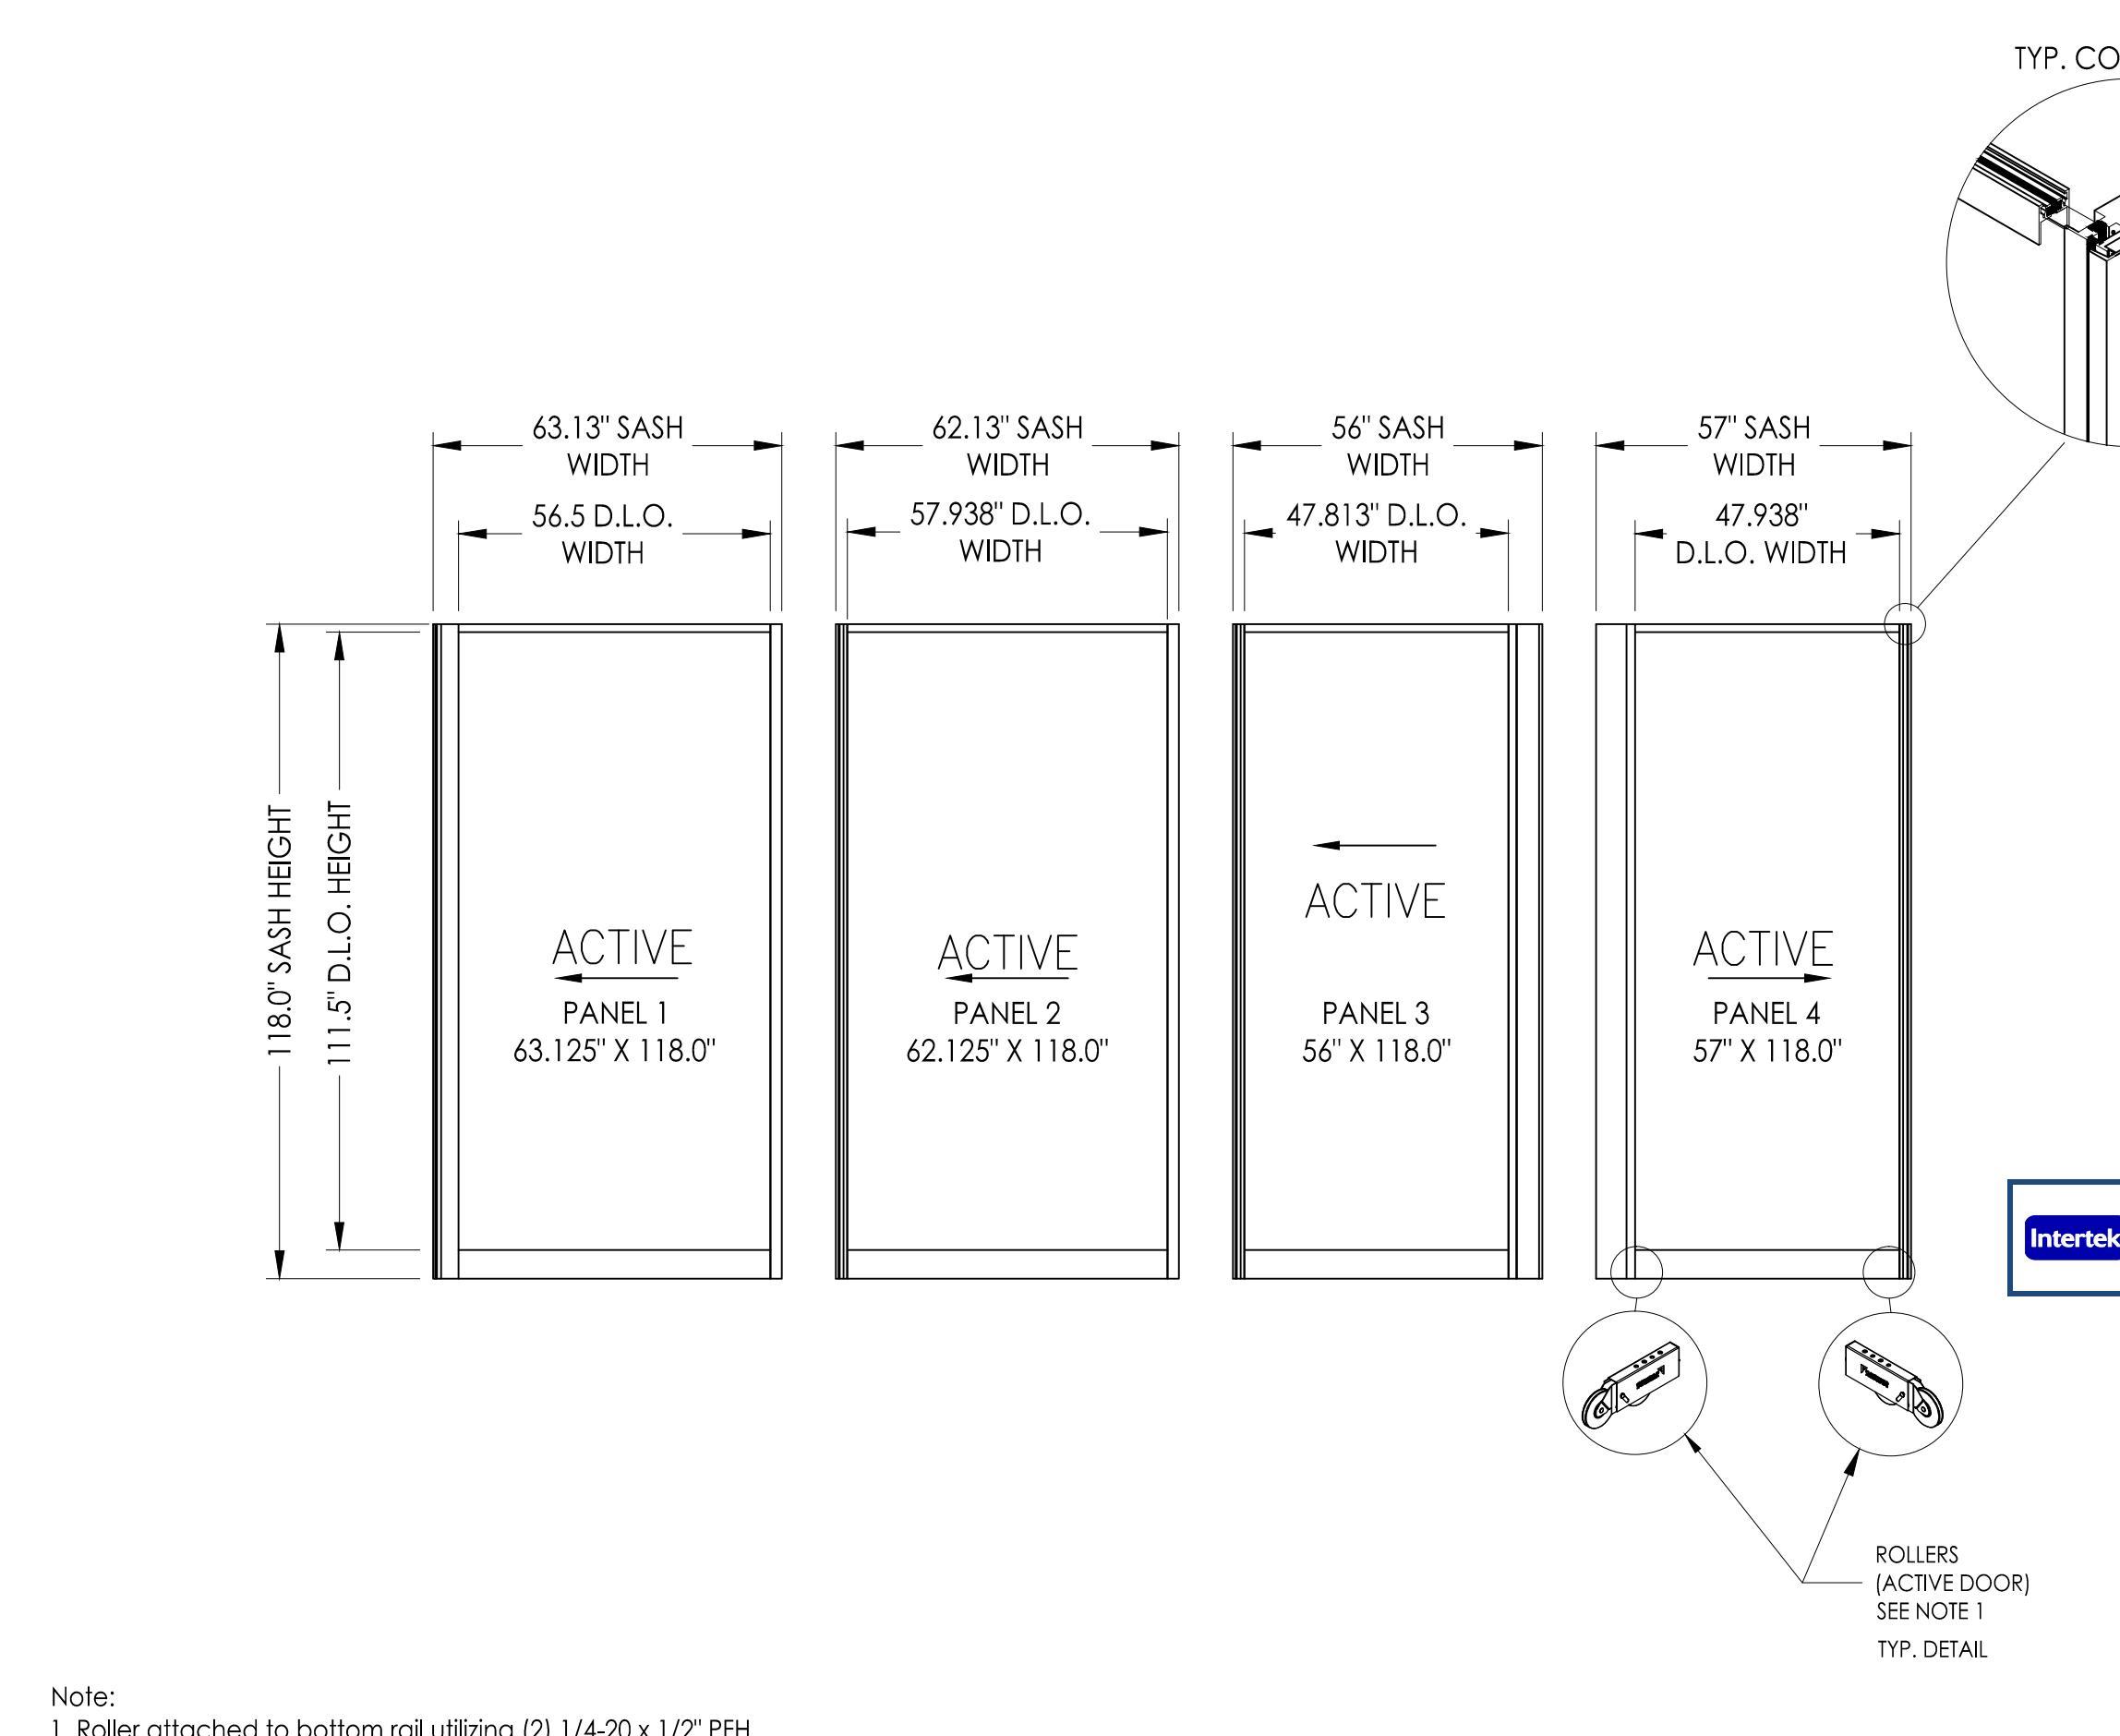
1. Roller attached to bottom rail utilizing (2) 1/4-20 x 1/2" PFH Screw and attached to Stile utilizing (2) 1/4 -20 x 1" PPH Screw.

Joinery Type	Detail
All corners	Butt	Sealed with silicone. Top corners fastened with two #8 x 3.5" Phillips head screw each. Bottom corners fastened with two #8 x 3.5" and two 1/4-20 x 1" Phillips head screw.

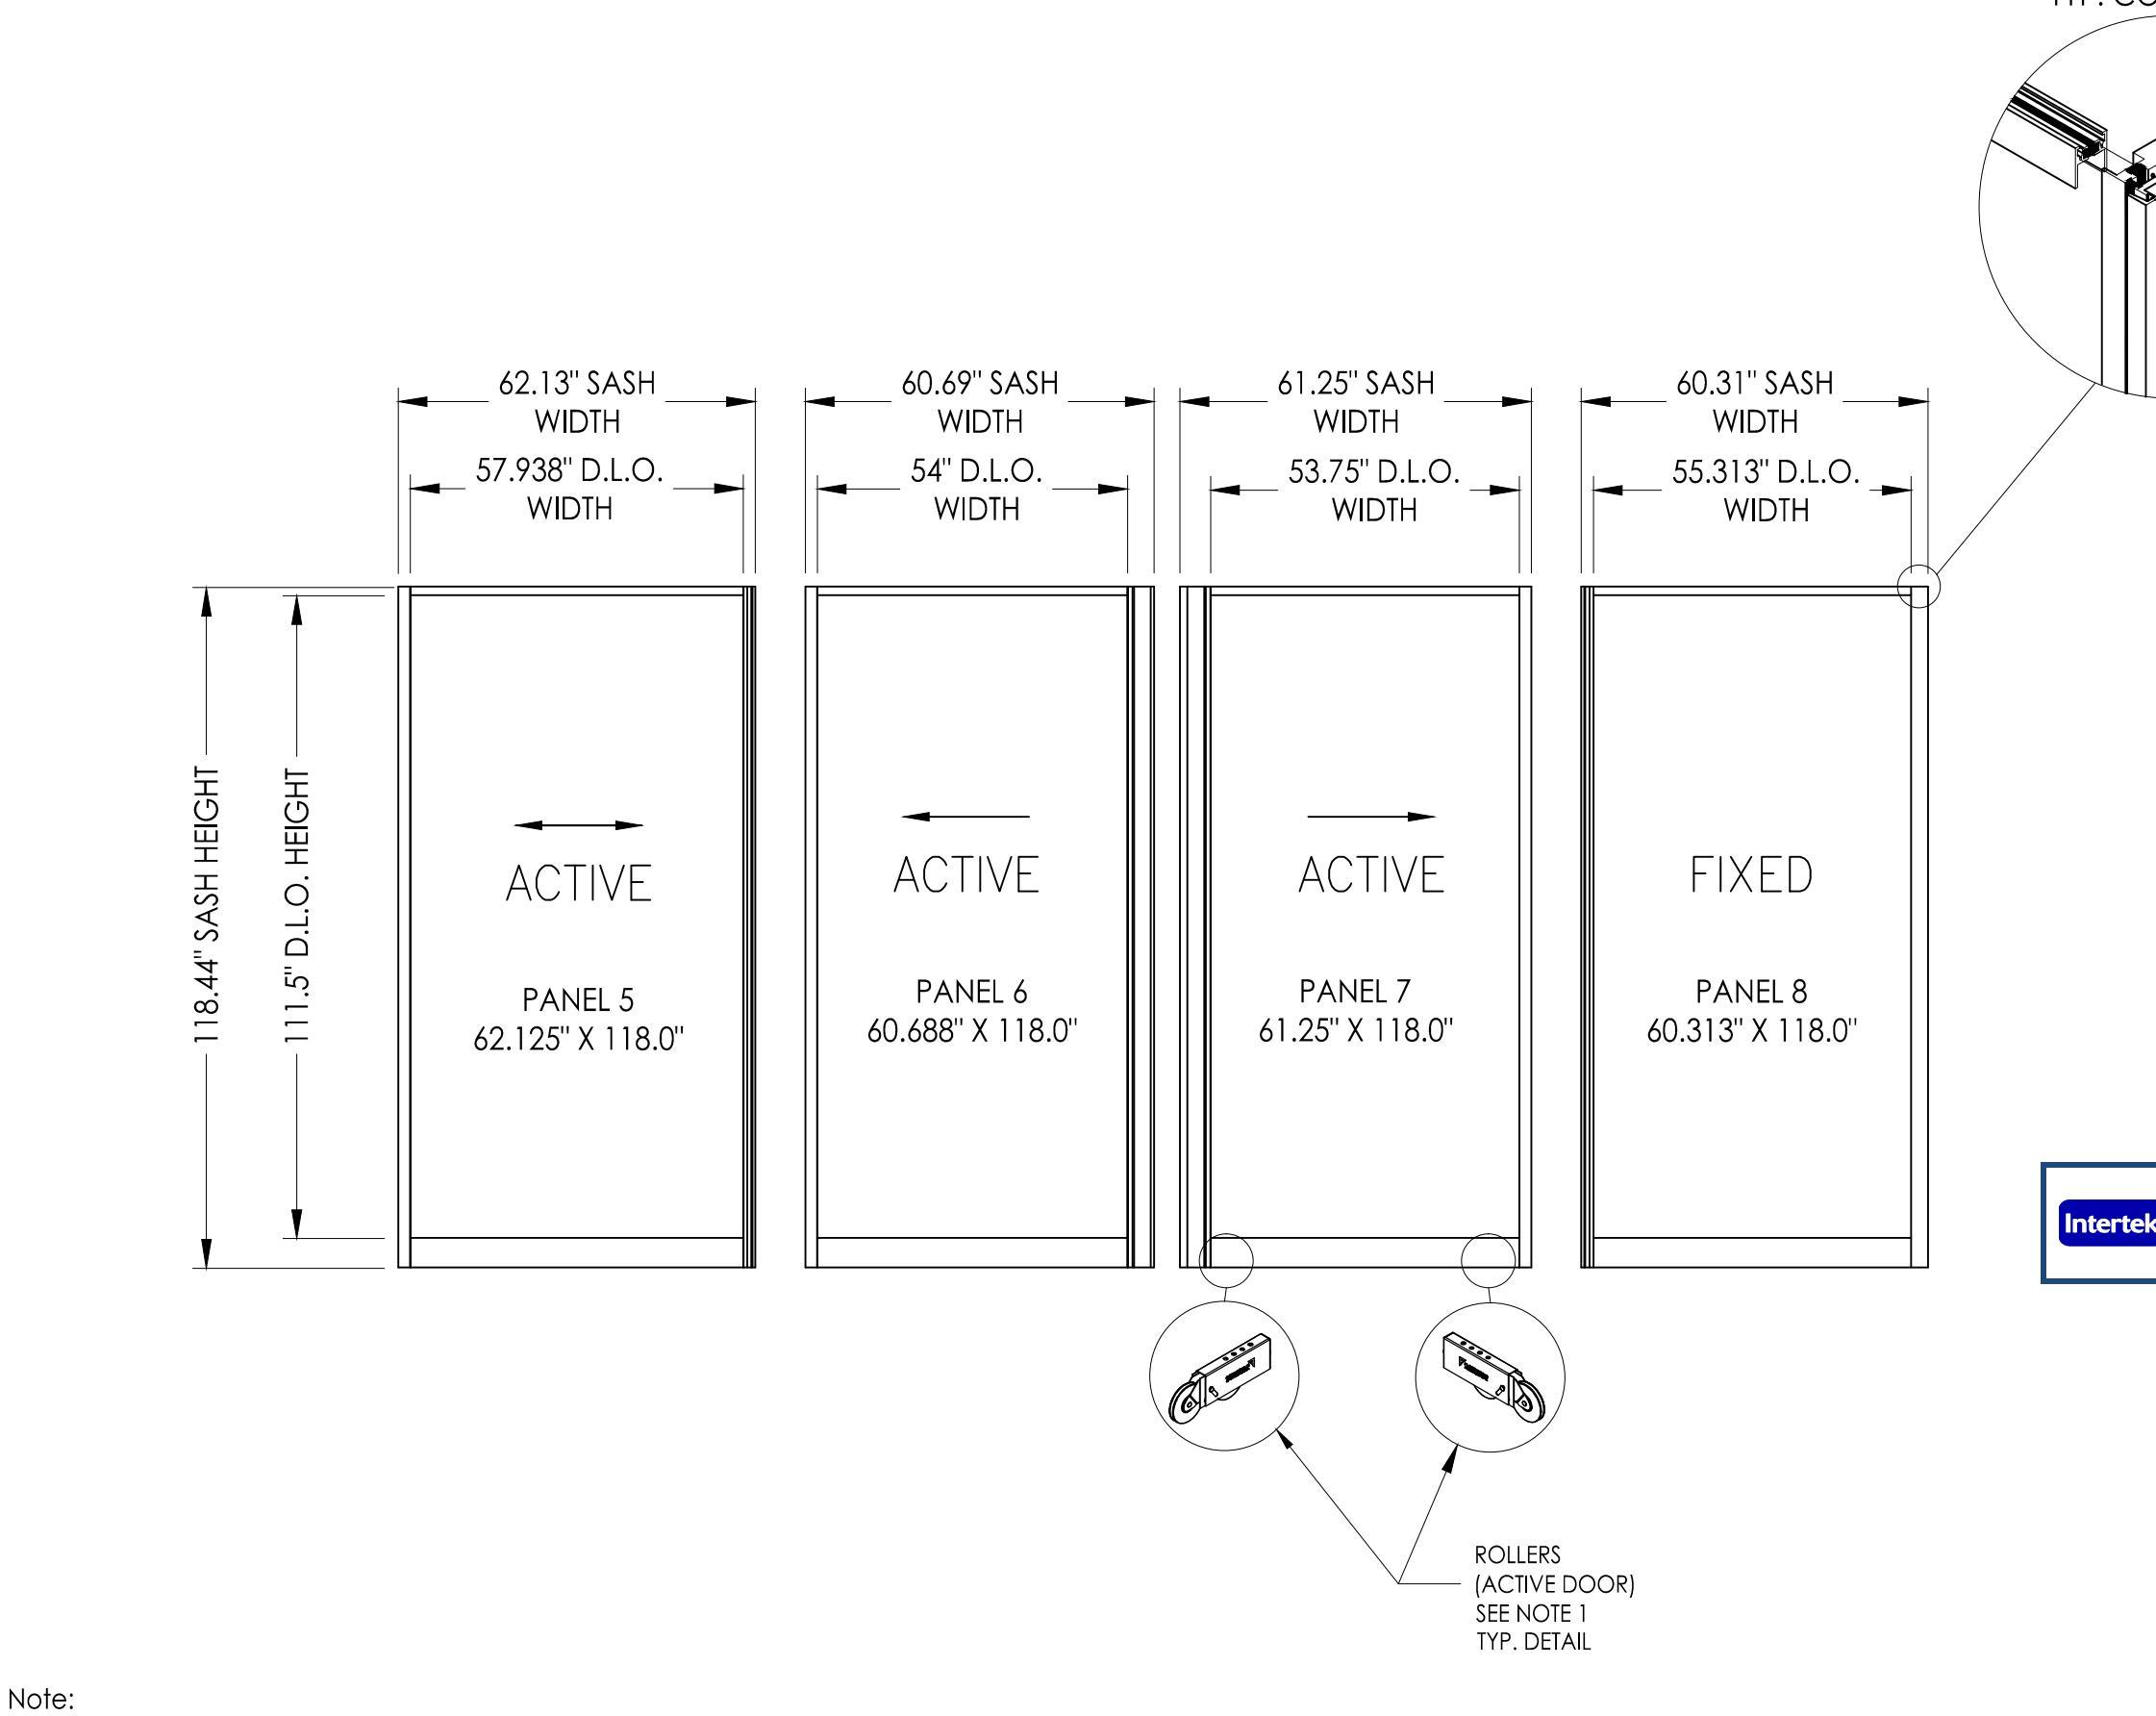
1. Roller attached to bottom rail utilizing (2) 1/4-20 x 1/2" PFH Screw and attached to Stile utilizing (2) 1/4 -20 x 1" PPH Screw. TYP. CC

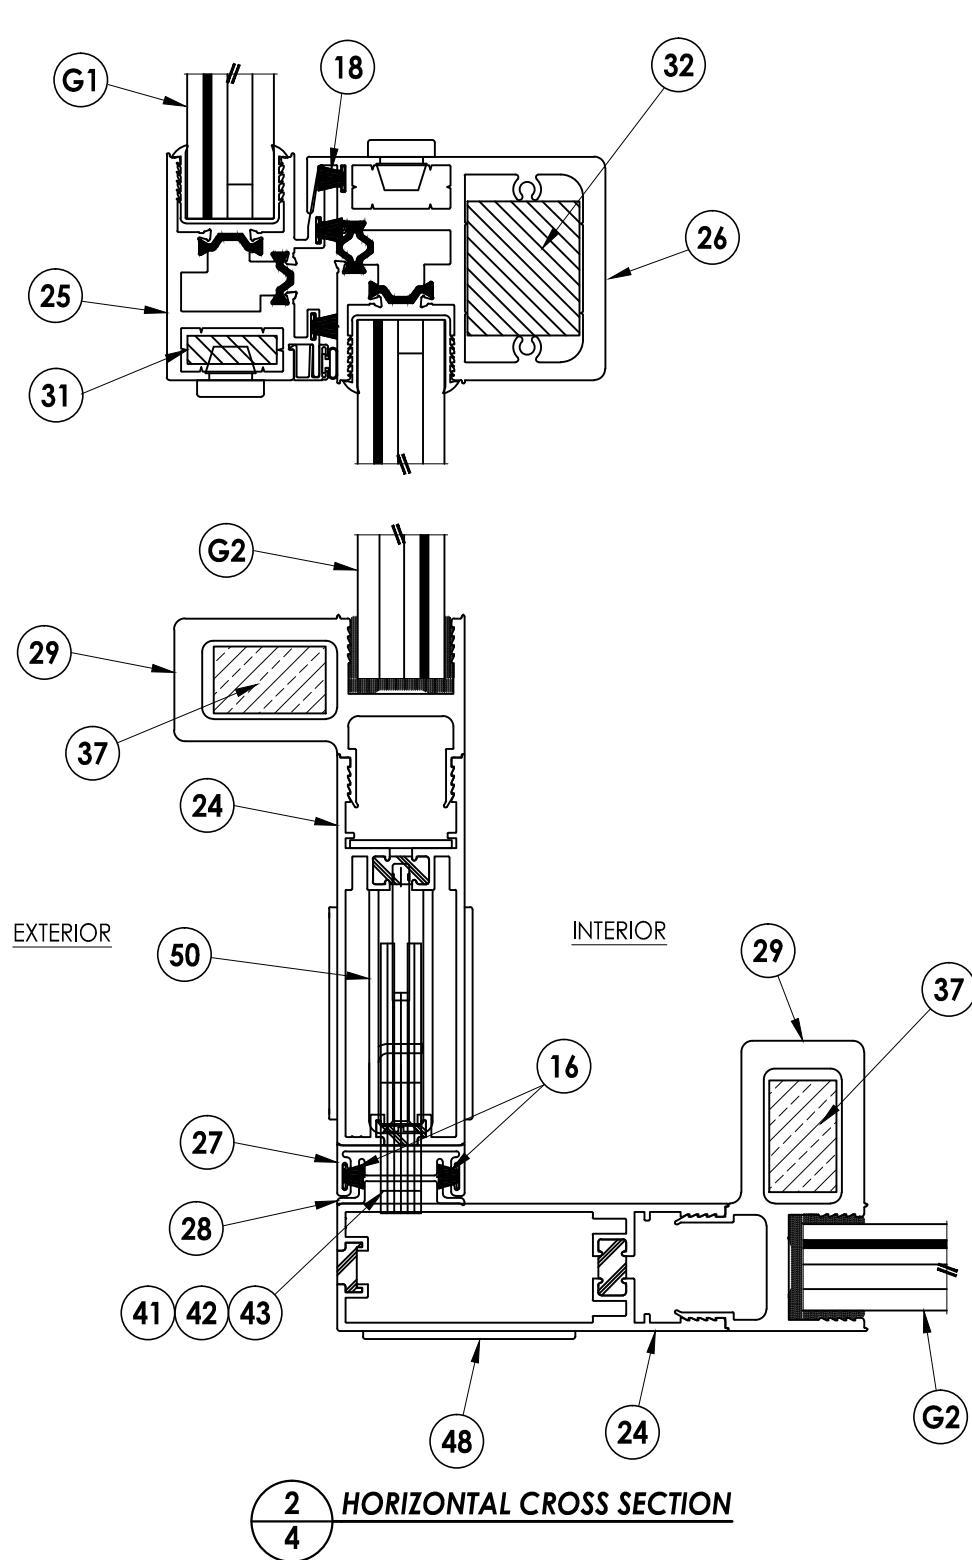
NOTE: 1.8" from each end then 12" on center

(37)

Drawing Number	Location	Material
37	All small interlock hallows	Aluminum
38	All small interlock hallows	Aluminum

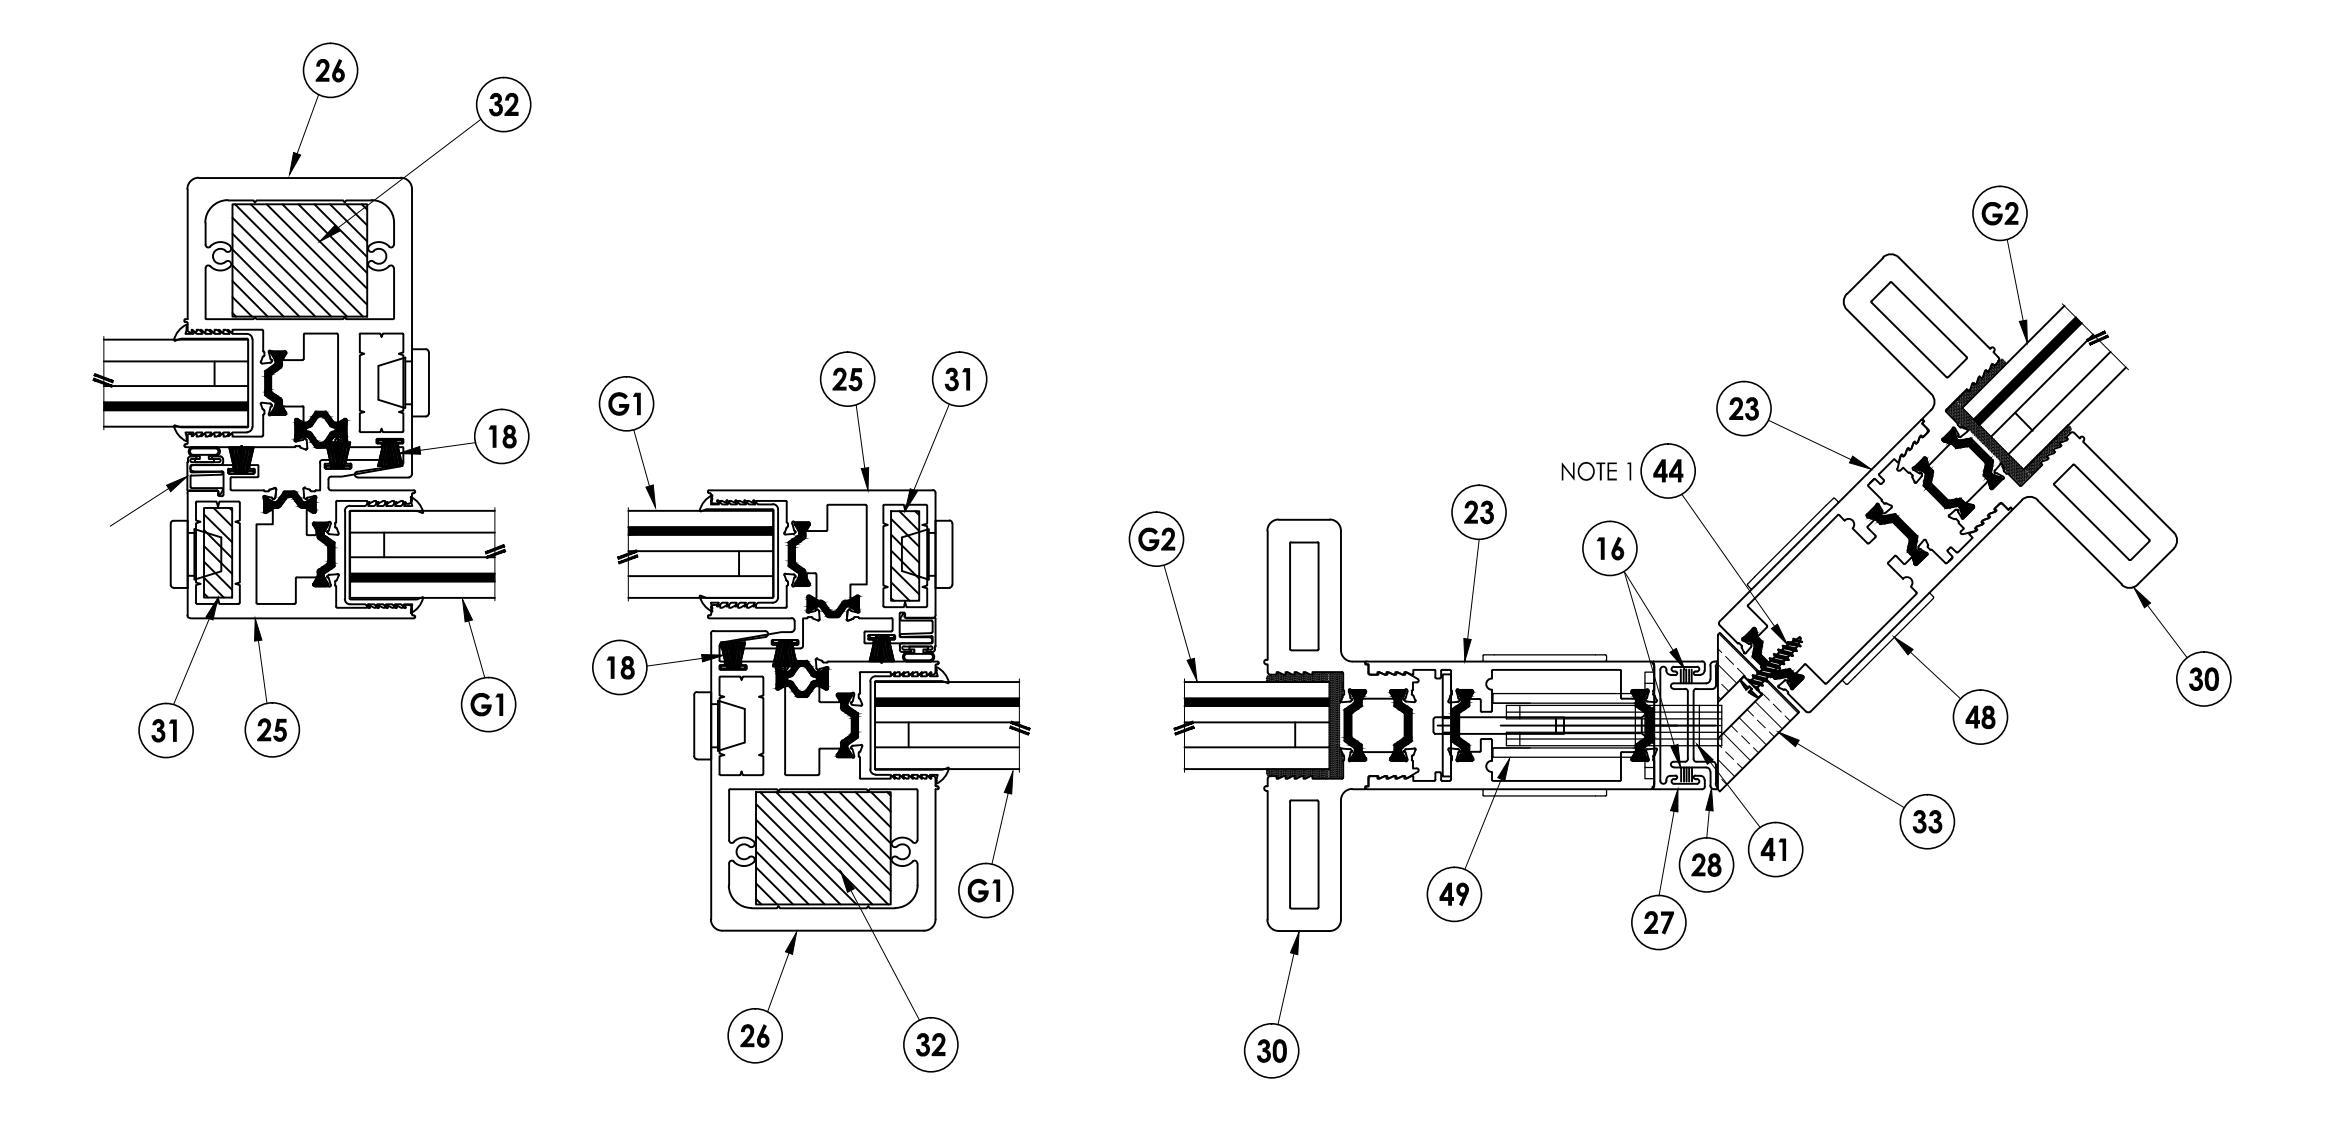
NOTE: 1. 6" from each end then 18" on center

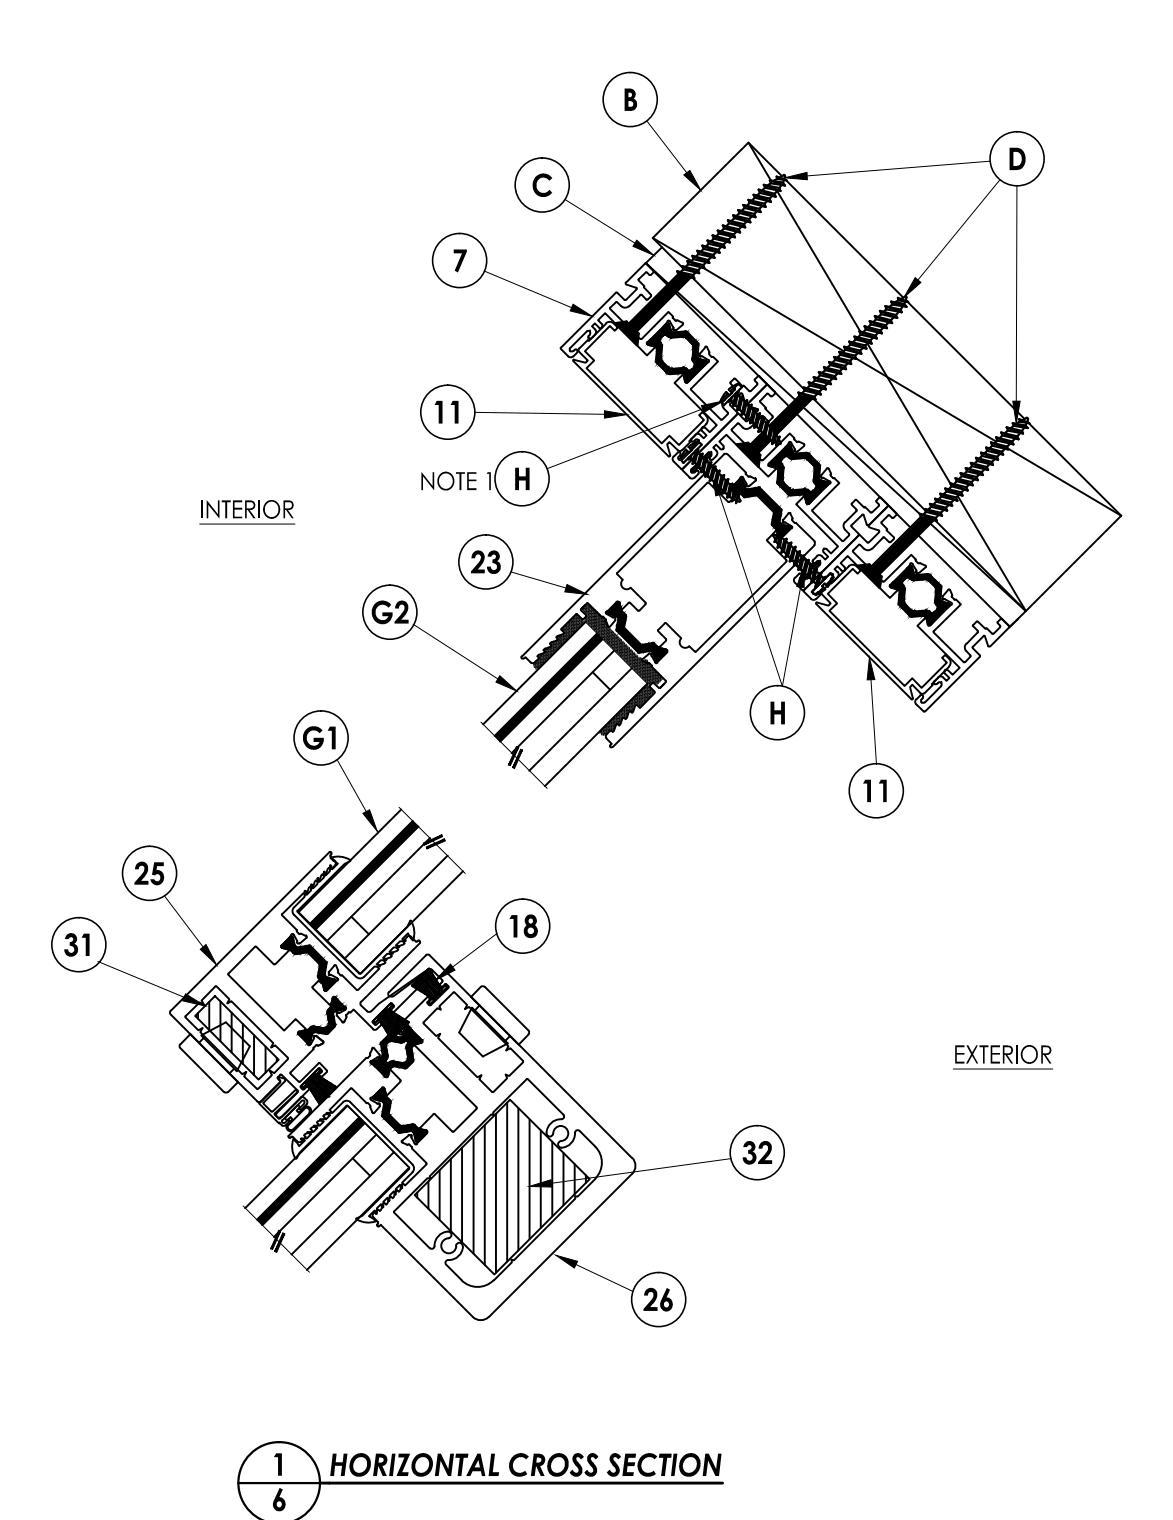
1.1" from each end then 60" on center

2. Interior or exterior (gasket cut 2" from top rail and bottom rail on stile).

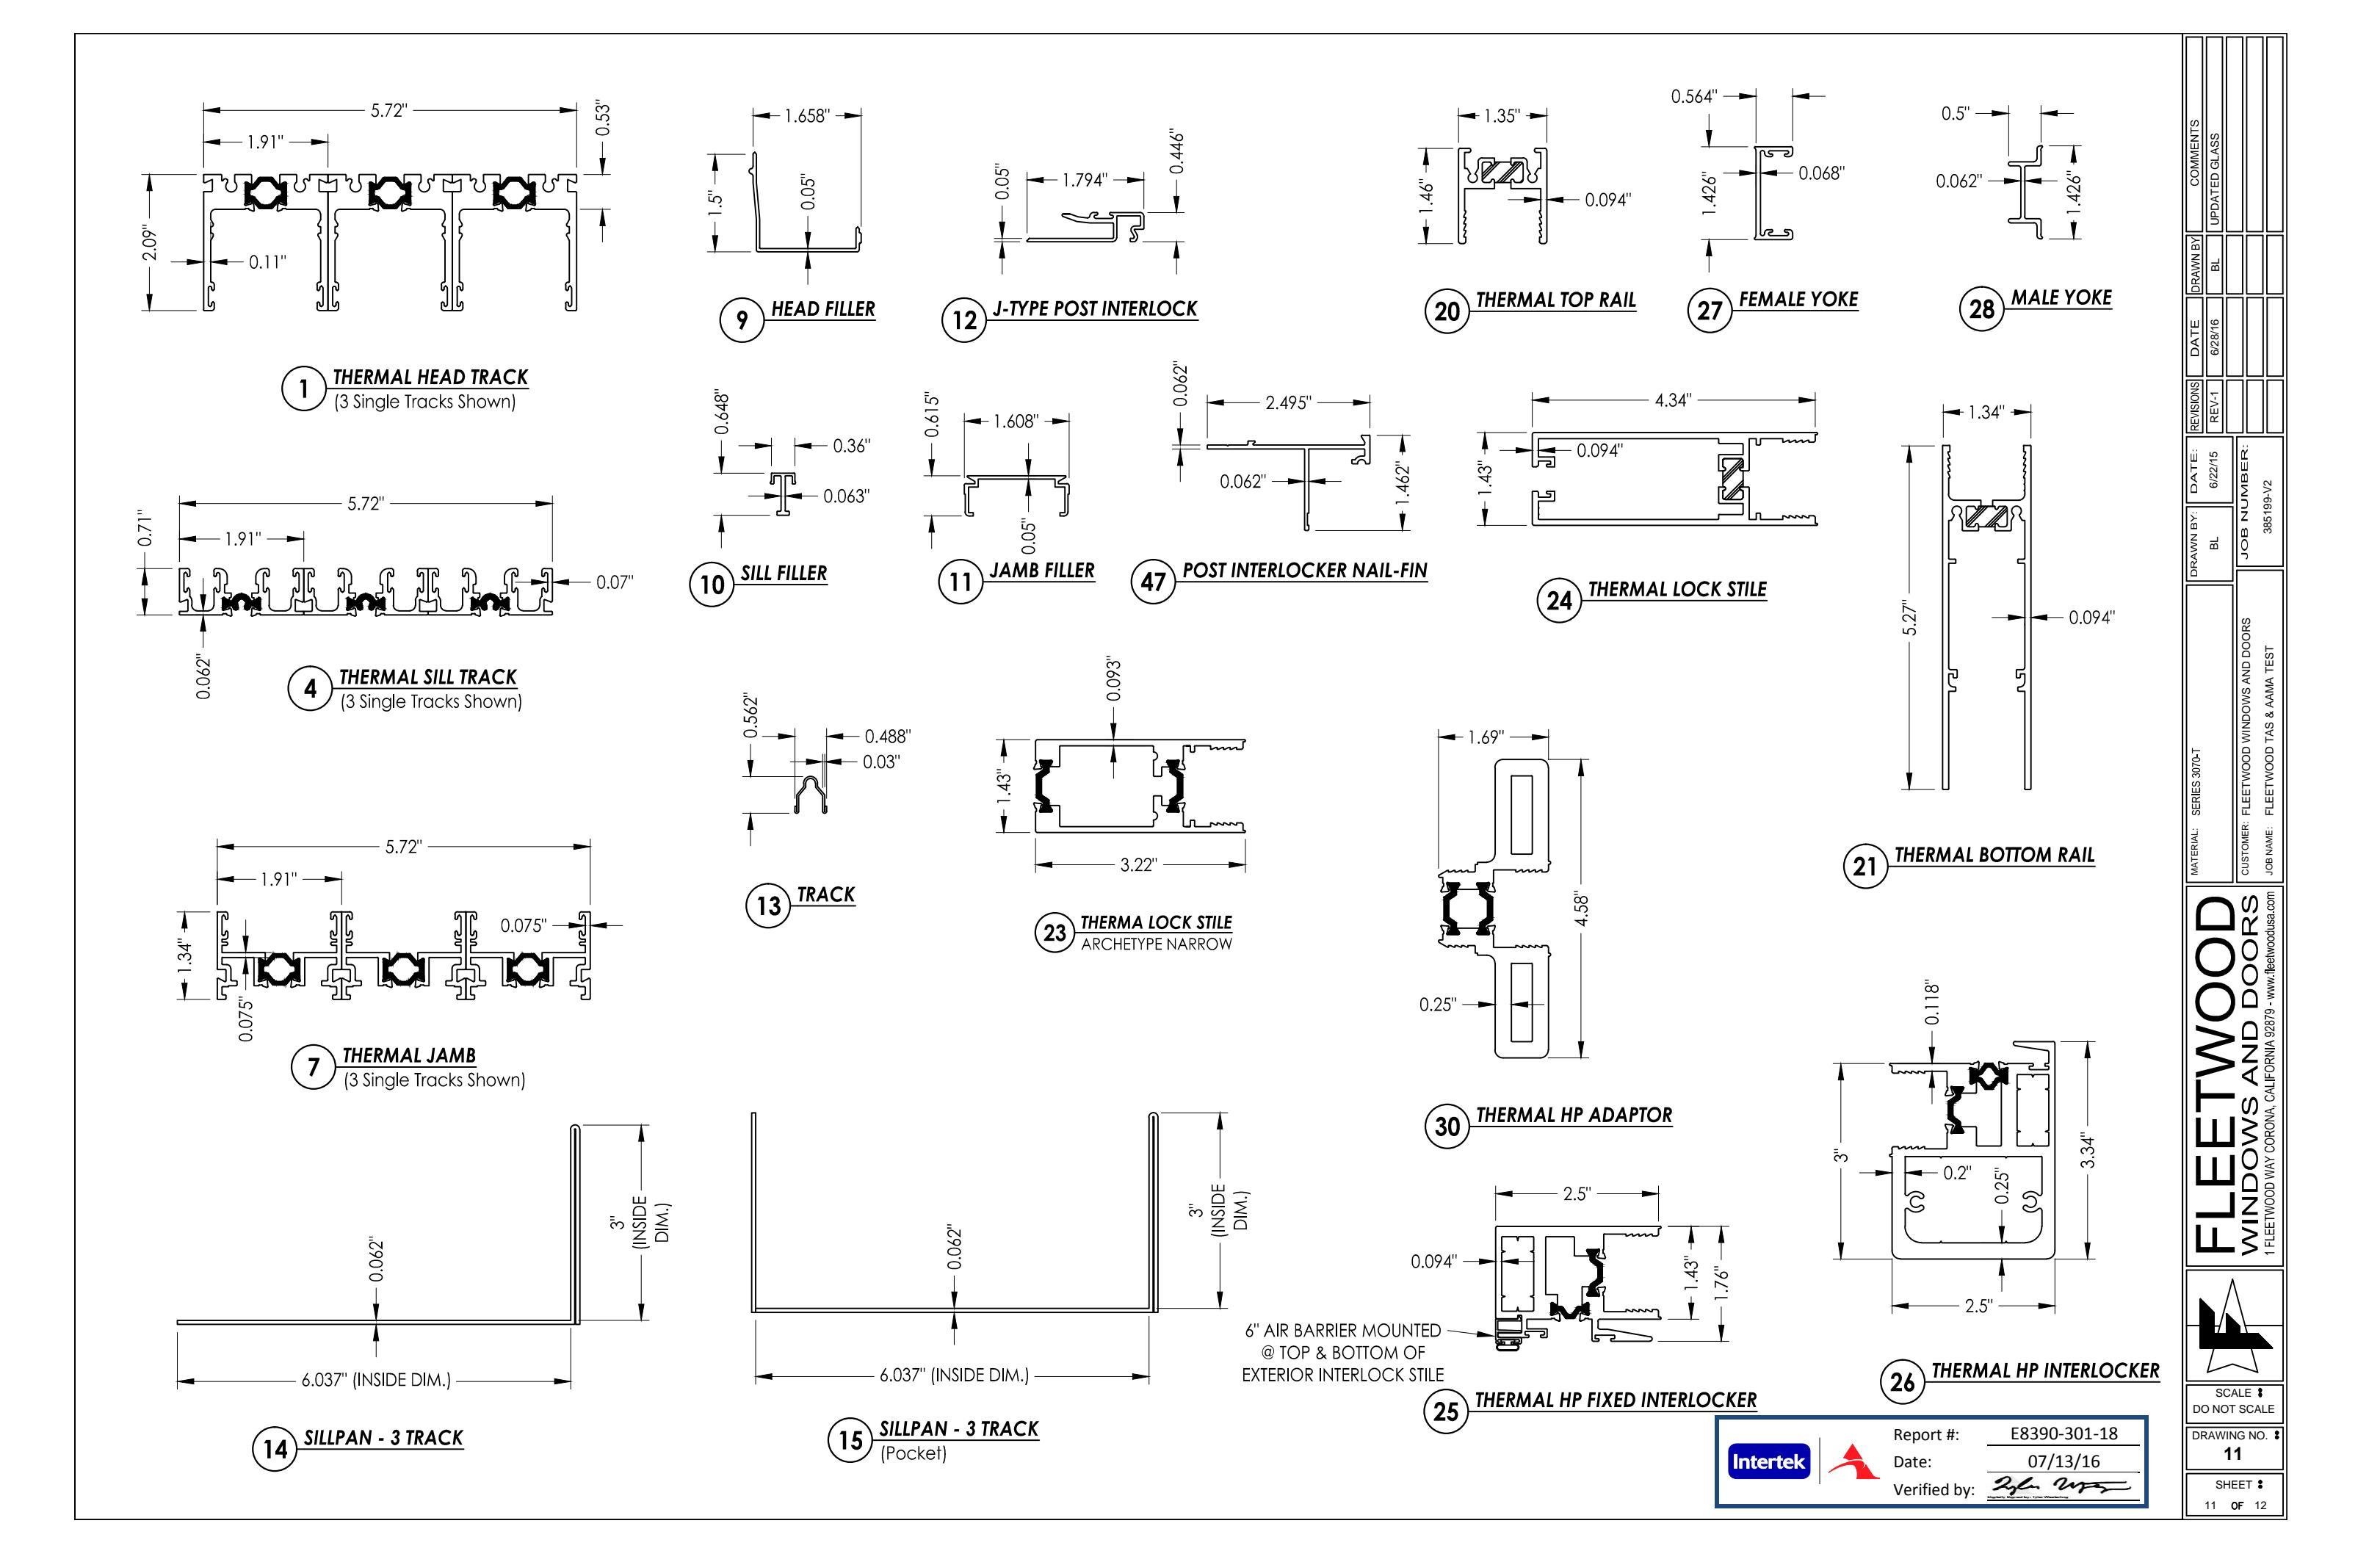
BILL OF MATERIALS						
ITEM #	DESCRIPTION	PART#	MATERIAL			
В	2X BUCK SG >= 0.55	N/A	WOOD			
С	1/4" MAX. SHIM SPACE	N/A	-			
D	#10 x 2-1/2" PFH WOOD SCREW	N/A	STEEL			
F	#10 x 2" PPH WOOD SCREW	N/A	STEEL			
G	#8 x 1-1/2" PFH WOOD SCREW	N/A	STEEL			
Н	#8 x 3/4" PPH SMS	N/A	STEEL			
1	THERMAL HEAD (SINGLE TRACK)	3700	6063-T6 ALUM			
4	THERMAL SILL (SINGLE TRACK)	3749	6063-T6 ALUM			
7	THERMAL JAMB (SINGLE TRACK)	3711	6063-T6 ALUM			
9	HEAD FILLER	3014	STAINLESS STELL			
10	SILL FILLER	3747	STAINLESS STELL			
11	JAMB FILLER	3710	STAINLESS STELL			
12	J-POST INTERLOCKER SNAP-IN	3755	STAINLESS STELL			
13	S.S. TRACK	FW1020	-			
14	SILL PAN (3-TRACK)	3720-3	-			
15	SILL PAN (3-TRACK)(POCKET)	3720-3	-			
16	SMALL FIN SEAL .230	19118	6063-T6 ALUM			
17	9/16" GLAZING VINYL (ASTM C864)	25033	6063-T6 ALUM			
18	LARGE FIN SEAL .290	19117	6063-T6 ALUM			
19	Q-LON (U5212)	19120	6063-T6 ALUM			
20	THERMAL TOP RAIL	3004	6063-T6 ALUM

21	THERMAL BOTTOM RAIL	3027	6063-T6 ALUM			
23	LOCK STILE (ARCHETYPE NARROW)	3773	6061-T6 ALUM			
24	THERMAL LOCK STILE	3771	6061-T6 ALUM			
25	HP THERMAL FIXED INTERLOCKER	3728	6061-T6 ALUM			
26	HP THERMAL INTERLOCKER	3031	6061-T6 ALUM			
27	FEMALE YOKE	3040	6061-T6 ALUM			
28	MALE YOKE	3039	6061-T6 ALUM			
29	WINDLOAD ADAPTOR	3715	6061-T6 ALUM			
30	THERMAL HP ADAPTOR	3716	STAINLESS STEEL			
31	0.31" X 1" SOLID ALUMINUM	N/A	6061-T6 ALUM			
32	1.25" X 1.5" SOLID ALUMINUM	N/A	6061-T6 ALUM			
33	135° SOLID YOKE BLOCK (ALUMINUM)	N/A	6061-T6 ALUM			
37	0.75" X 1.25" SOLID ALUMINUM	N/A	6061-T6 ALUM			
38	AIR BARRIER (SILL)	25383	-			
39	AIR BARRIER (HEAD)	24097	-			
40	6" AIR BARRIER FOR HP INTERLOCKER	25562				
41	STRIKE PLATE	24980	STEEL			
42	BACK UP PLATE	24981	STEEL			
43	10-32 X .5" FHP	N/A	STEEL			
44	#10 X 1" PHP	N/A	STEEL			
45	#8 TEK X 1/2"	N/A	STEEL			
46	DOW 995 SILICONE	N/A	-			
47	POST INTERLOCKER NAIL-FIN	3756	6061-T6 ALUM

48	FLUSH PULL	-	S.S.			
49	ARCHETYPE NARROW LOCK	-	=			
50	ARCHETYPE LOCK	-	-			
51	ARCHETYPE ROLLERS	-	<u> </u>
